**2014 / 2015 STREAM MONITORING REPORT
WILLIAMSON COUNTY, TENNESSEE
TETRA TECH PROJECT NO. 103S3287**

Williamson County Engineering Department
1320 West Main Street #400
Franklin, TN 37064
Attn: Mr. Michael Scott

September 23, 2015

Tetra Tech, Inc.
712 Melrose Avenue
Nashville, Tennessee 37211

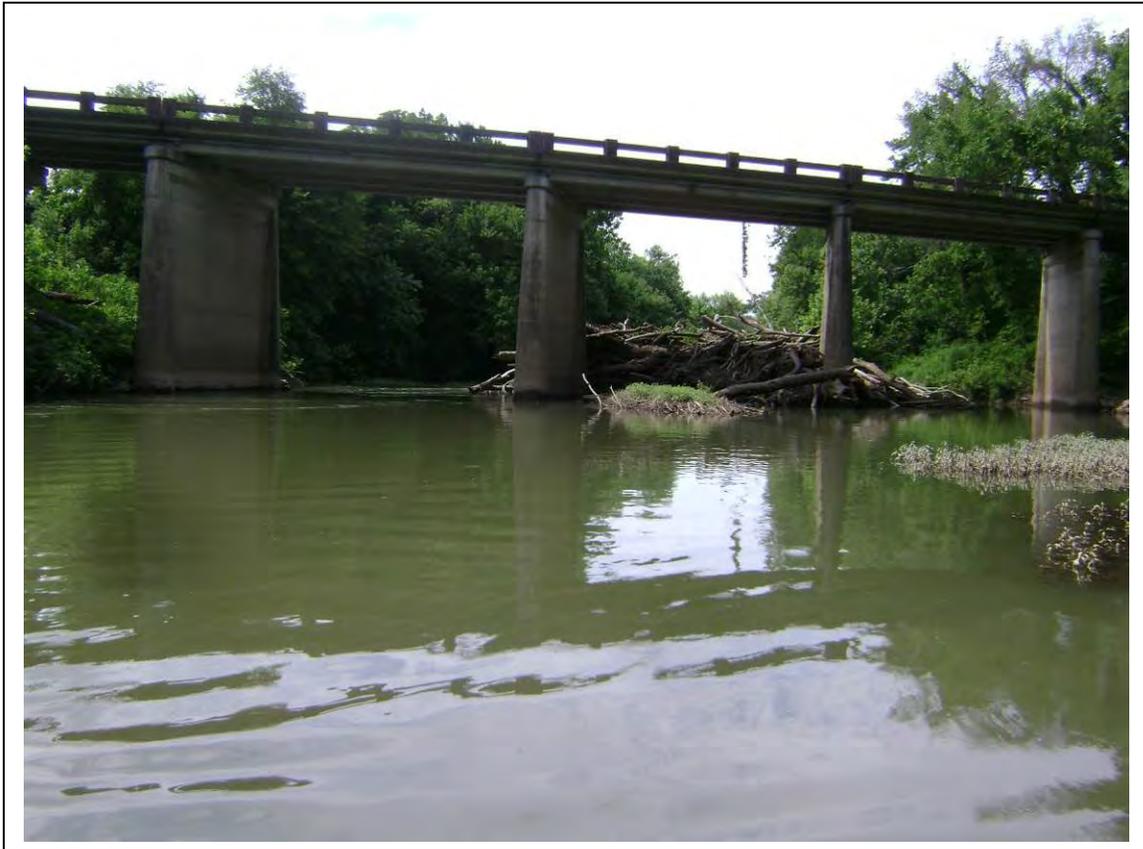
The Harpeth River at Sneed Road sampling site was located downstream of a bridge on Sneed Road in an area of agricultural row crops and residential development. The stream reach has been channelized. A large log jam was observed above the bridge. The riparian area consisted of primarily hardwood and shrubs. The stream sampling reach was approximately 115 feet wide and was mostly unshaded due to its width. The average depth of the reach was 3.6 feet and it consisted of pools and runs; no riffles were present. The substrate was predominantly boulder and cobble. Rooted emergent vegetation, primarily water willow, and attached algae were observed near the banks. Sampling was performed during high water conditions due to recent rains.

Description:	View of the Harpeth River at Sneed Road chemical sampling site facing upstream.
---------------------	---

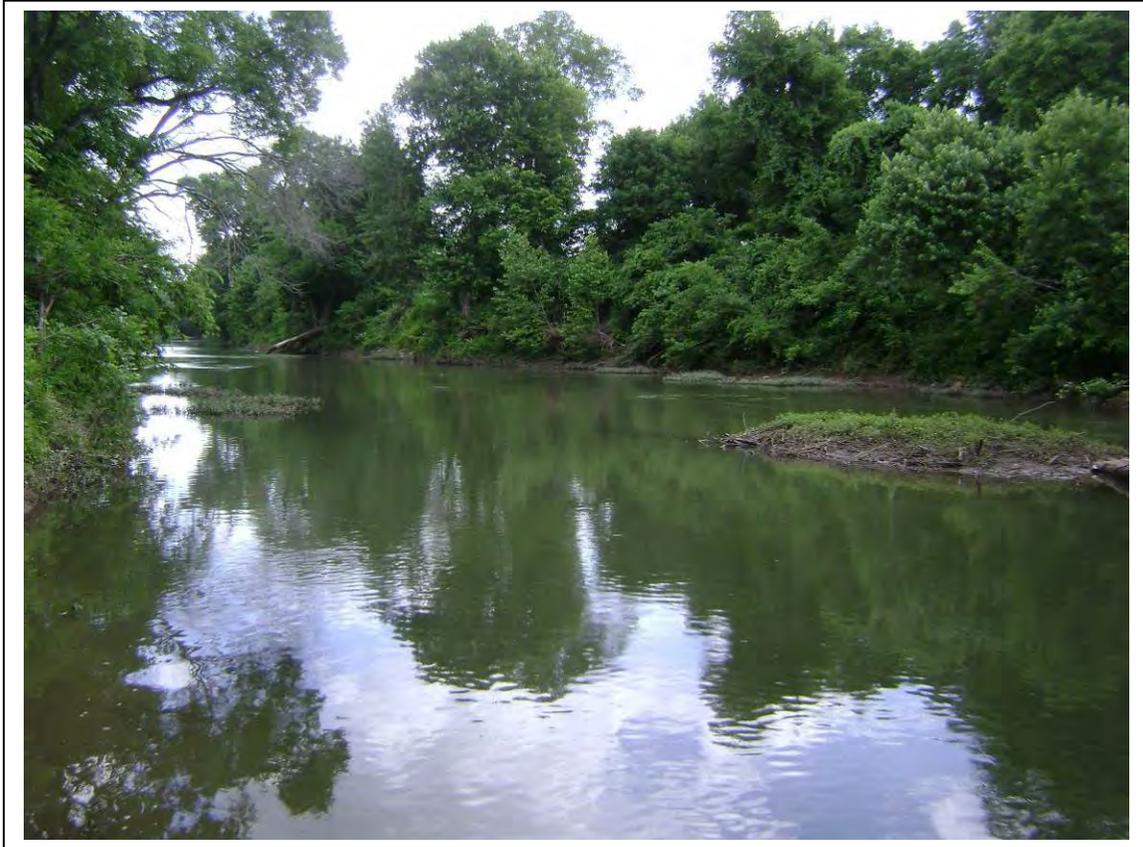
Description:	View of the Harpeth River at Sneed Road chemical sampling site facing downstream.
---------------------	---

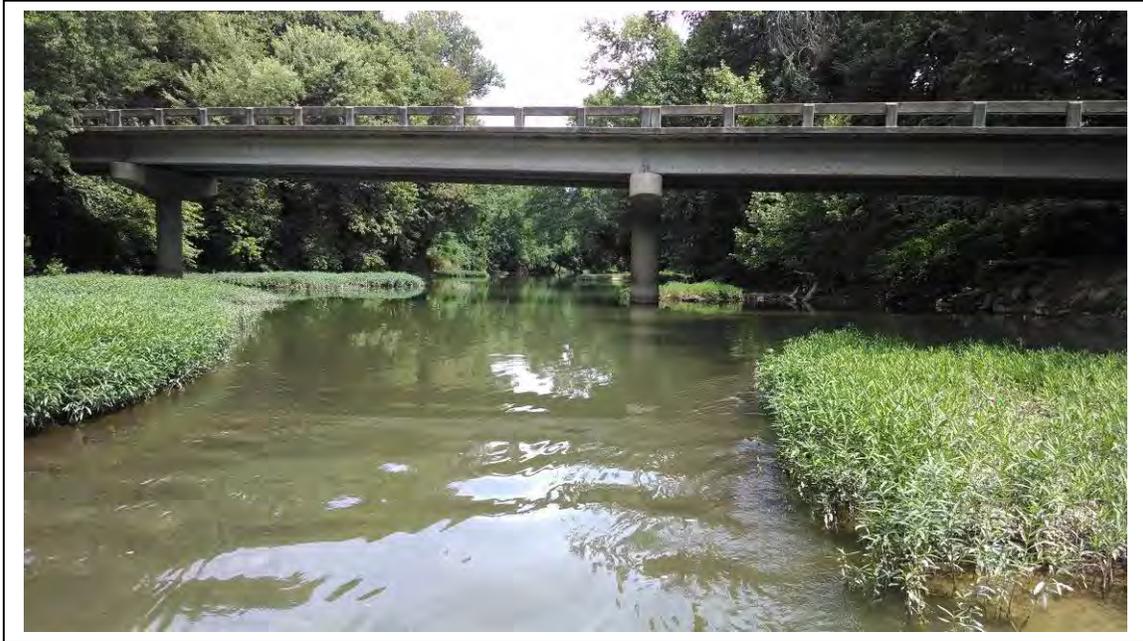
Description:	View of the Harpeth River at Moran Road chemical sampling site facing upstream.
---------------------	---

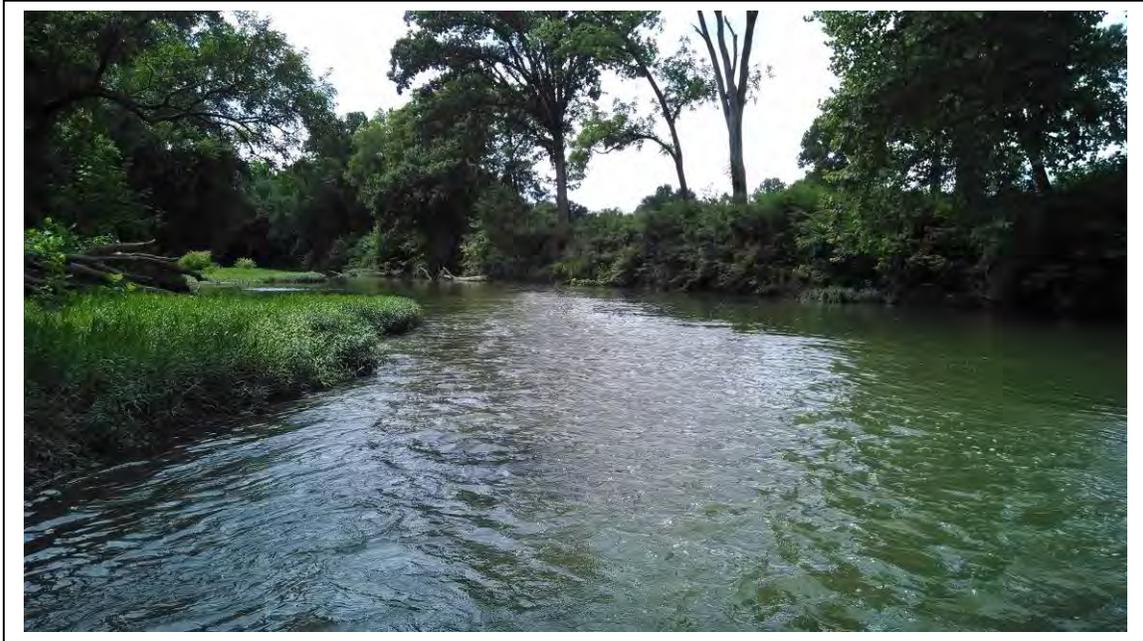
Description:	View of the Harpeth River at Moran Road chemical sampling site facing downstream.
---------------------	---

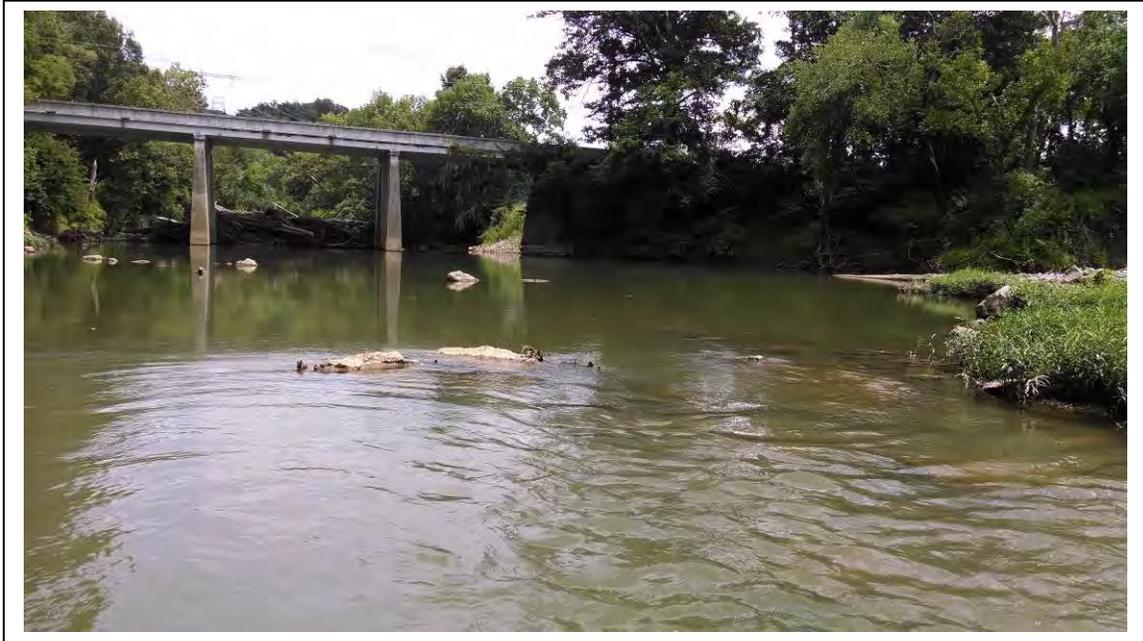
Description:	View of the Harpeth River at Old Hillsboro Road chemical sampling site facing upstream.
---------------------	---

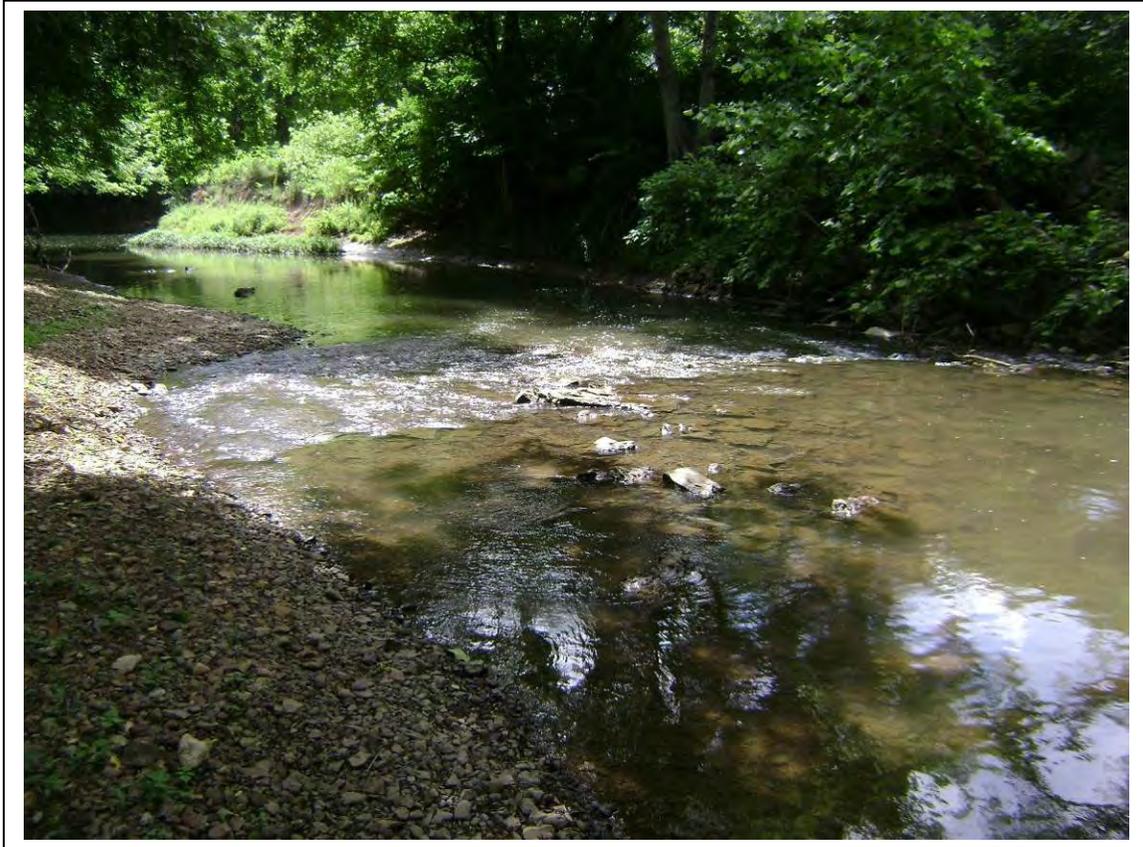
Description:	View of the Little Harpeth River at Vaugh Road biological sampling site facing downstream and showing one of the riffles sampled.
---------------------	---

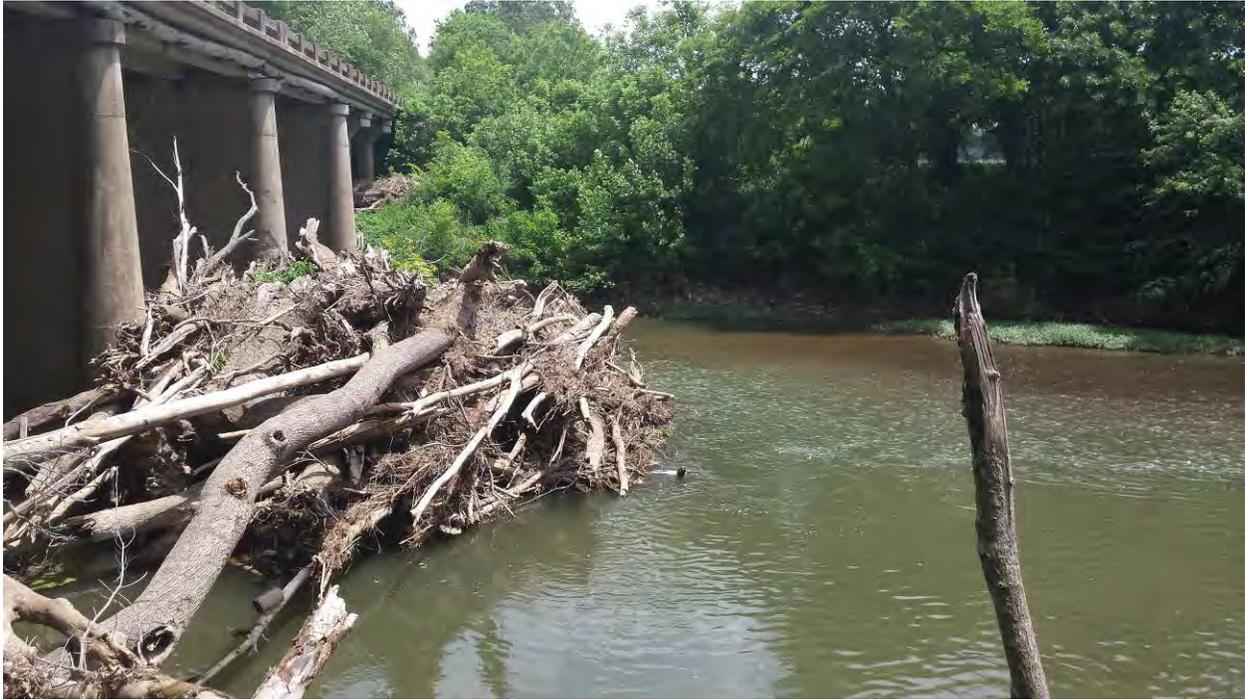
An Unusual Condition and erosion were identified at Harpeth River at Sneed Road, VSA Site 1. Torrent flow debris was observed upstream above the bridge support piling and abutment. The debris is visible on historical aerial imagery viewed on GoogleEarth since at least 2011. The river depth appears to be shallow directly above the bridge. Torrent debris fields are a direct result of channelization and bank and shoreline erosion during high watershed flow events. Continued buildup of this material will have a negative effect on the structural integrity of the bridge during moderate to high river flow. Debris build up reduces the laminar flow through the structure and may induce significant turbulence increasing overall erosion of the river and bank destabilization. The condition was rated severe (2), with good correctability rating (2), and good access rating (2).

Description:	Additional view of VSA Site 1 showing the torrent flow debris across bridge pilings and across the stream, facing east.
---------------------	---

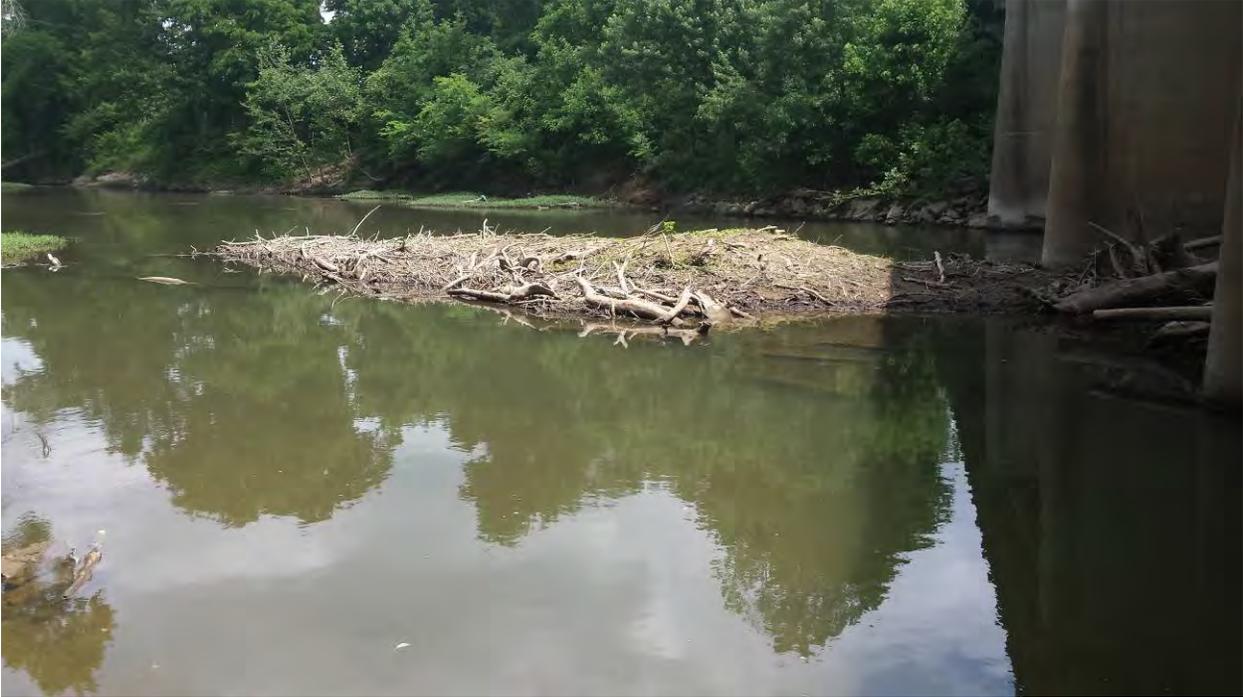
Description:	View of VSA Site 1 showing the torrent flow debris below the bridge, facing east.
---------------------	---

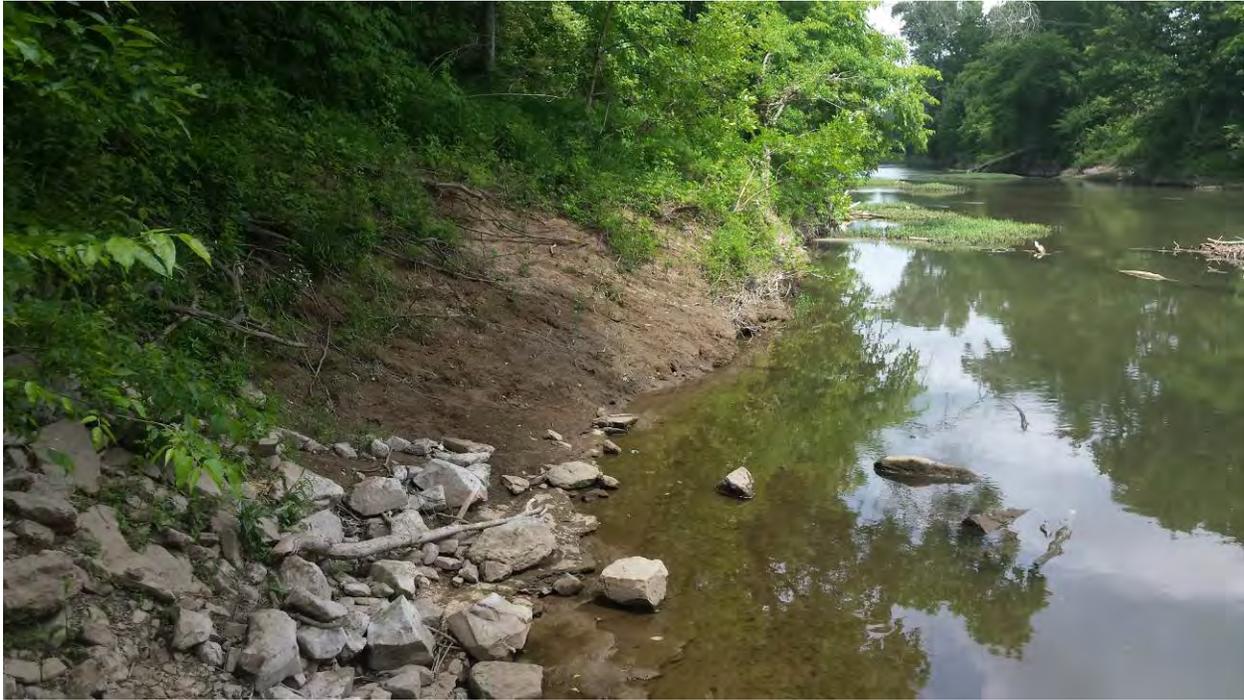
Moderate erosion of the river banks was also observed in the reach below the bridge road

crossing. The average area of exposed bank height is six feet. The condition's severity was rated minor (4) with a poor correctability (4) and accessibility (4) ratings.

Description:	View of VSA Site 1 showing erosion on the river bank below the bridge. Photograph taken facing north, downstream.
---------------------	---

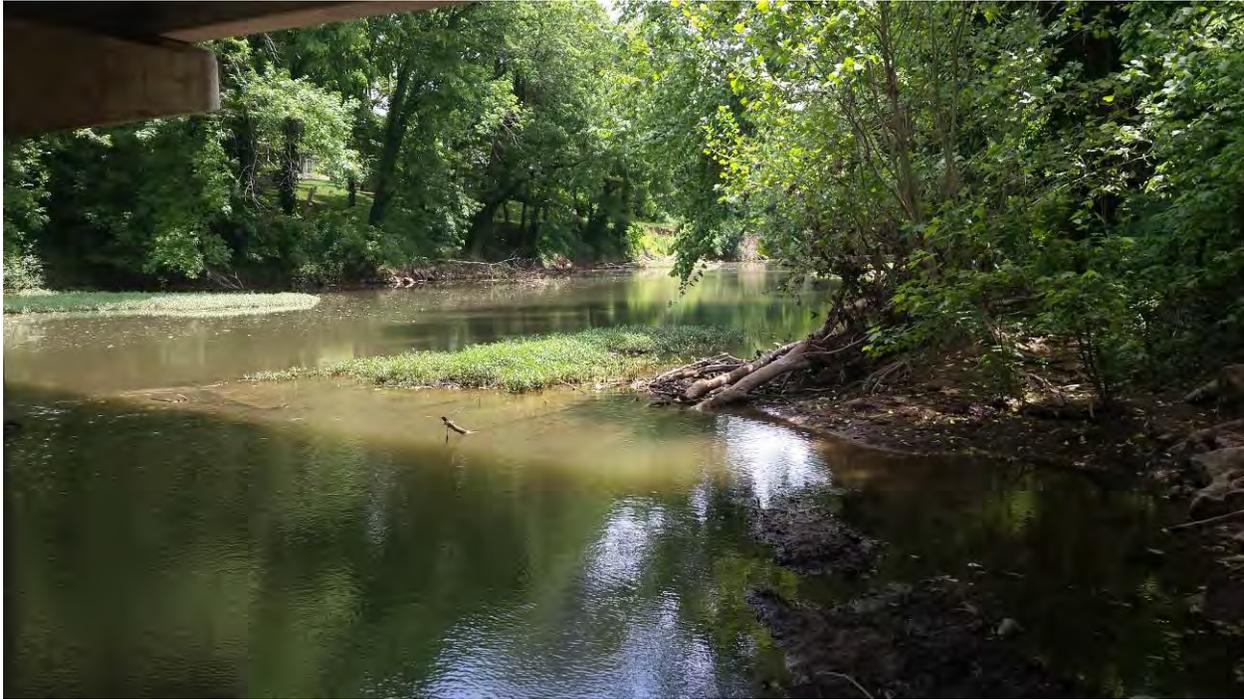
VSA Site 2, Harpeth River at Moran Road has an inadequate riparian buffer on the right bank. The mowed residential lawn is located beyond an approximate 10-foot right bank riparian buffer. The condition was given a minor severity rating (4) with moderate correctability (3), relatively good access (2), and low potential for construction of a wetland (5). Bank stabilization and establishment of a wider riparian buffer along the reach would help to lessen the in-stream impacts. Community education and outreach can be used to encourage residents to establish wider riparian buffers on their land.

Description:	View of VSA Site 2, Harpeth River at Moran Road, showing minor floodplain erosion and sediment bars in the stream reach. The residential lawn is visible in the left background of the photograph.
---------------------	--

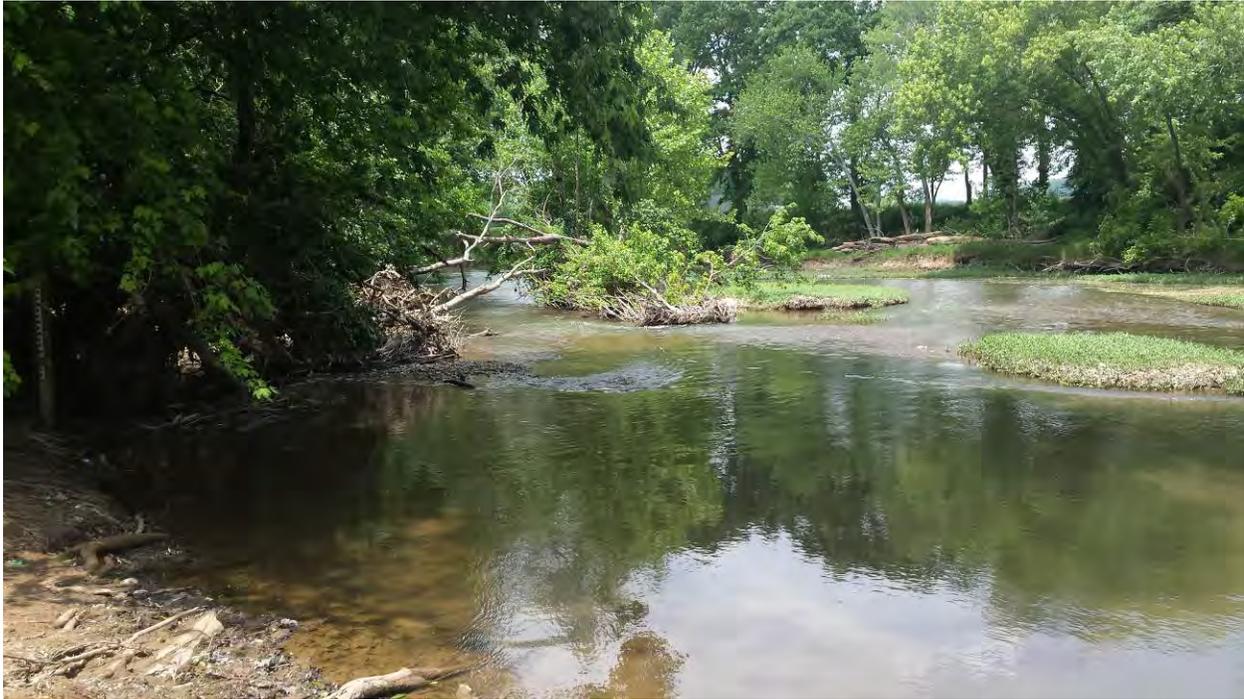
Description:	View of VSA Site 2, Harpeth River at Moran Road, showing erosion, and collapsing river banks.
---------------------	---

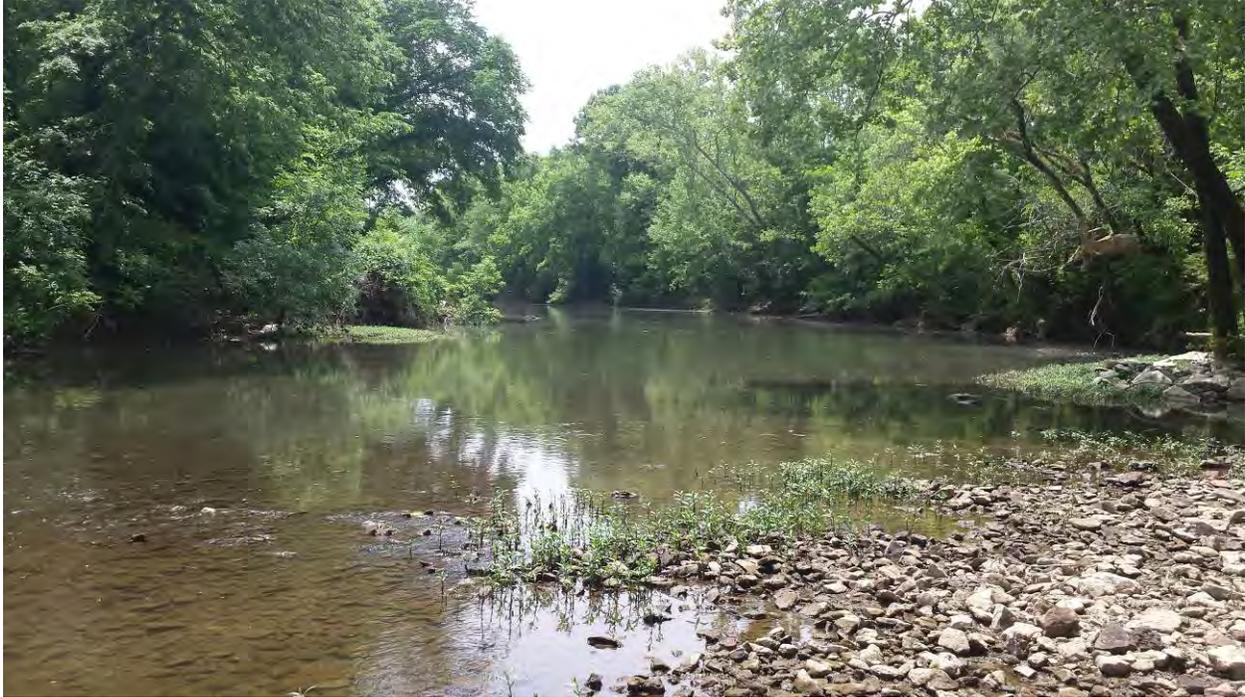
Description:	View of VSA Site 3, Harpeth River at Old Natchez Trace Road, a representative site.
---------------------	---

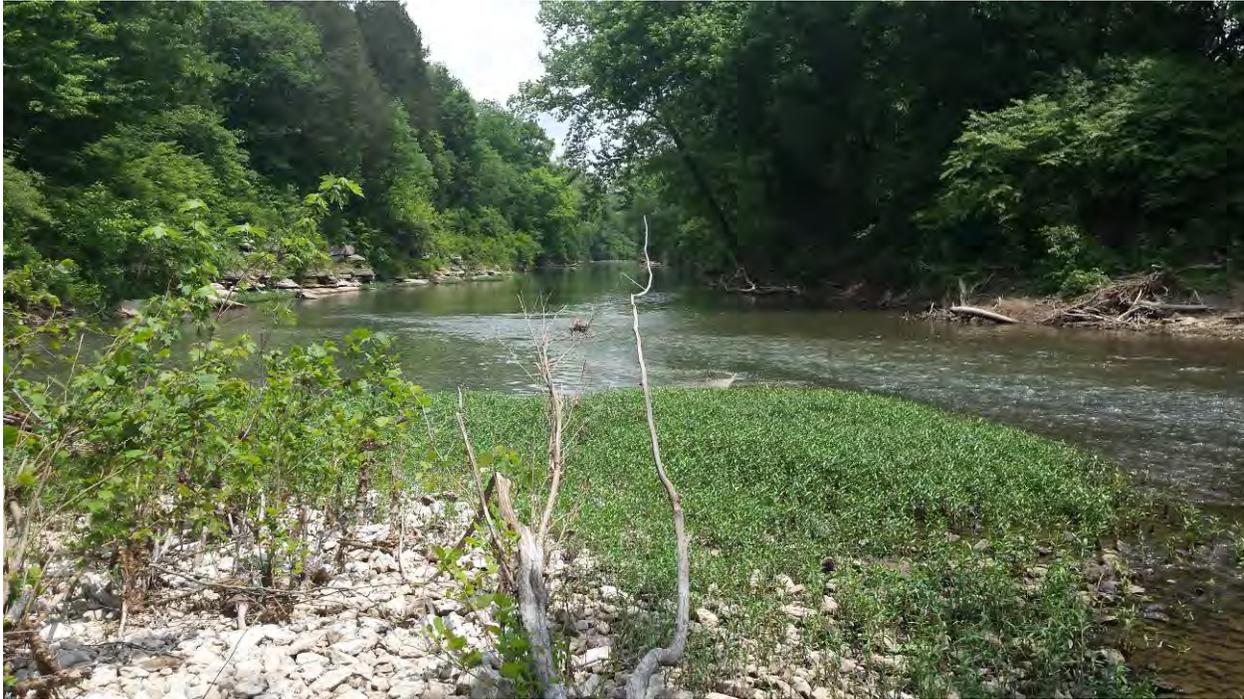
VSA Site 3, Harpeth River at Old Natchez Road, was selected by WCED as a representative site. The reach exhibits nominal bank erosion with riffle and pool habitat. Macroinvertebrate substrata, shelter for fish, velocity and depth, and channel flow were ranked optimal by WCED staff; embeddedness, bank vegetation, and bank condition were ranked suboptimal; and channel alteration, sediment deposition, and riparian vegetation were ranked as marginal. Of note, the riparian buffer on the west river bank is less than 50 feet wide due to the presence of Old Natchez Trace Road.

Description:	View of VSA Site 3, Harpeth River at Old Natchez Trace Road showing riffle pools and some torrent debris.
---------------------	---

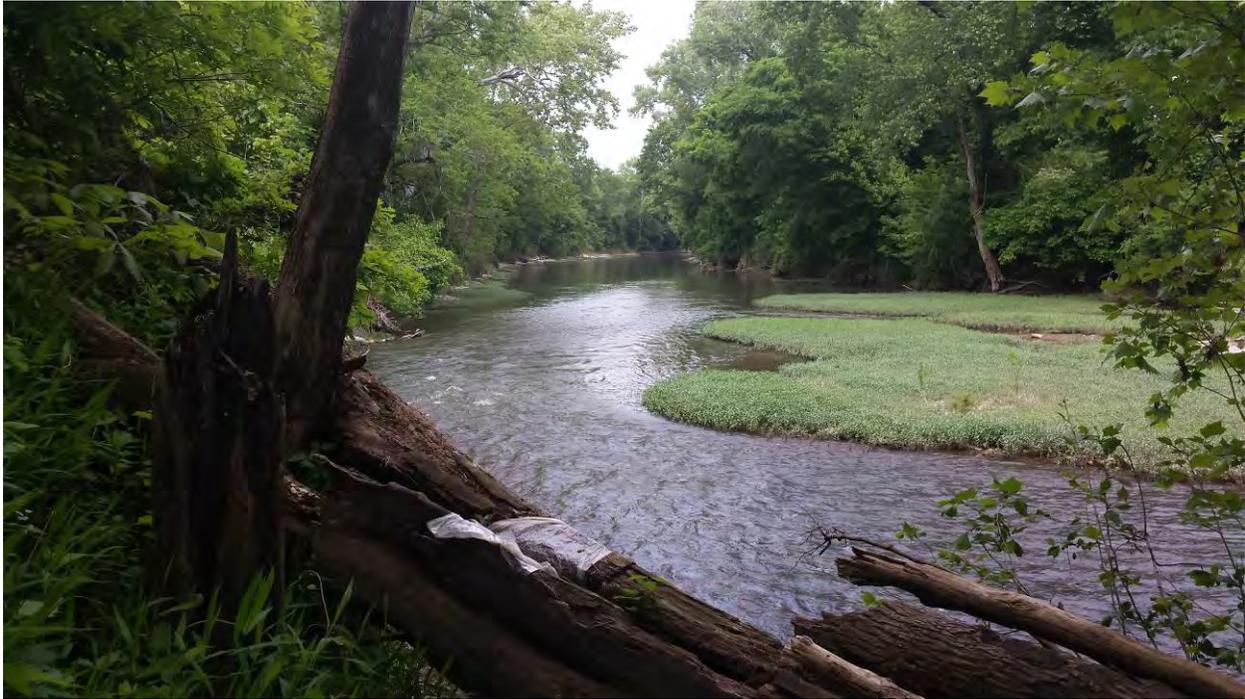
Description:	View of VSA 4 Site, Harpeth River at Old Natchez Trace and Lawrence Road showing torrent debris.
---------------------	--

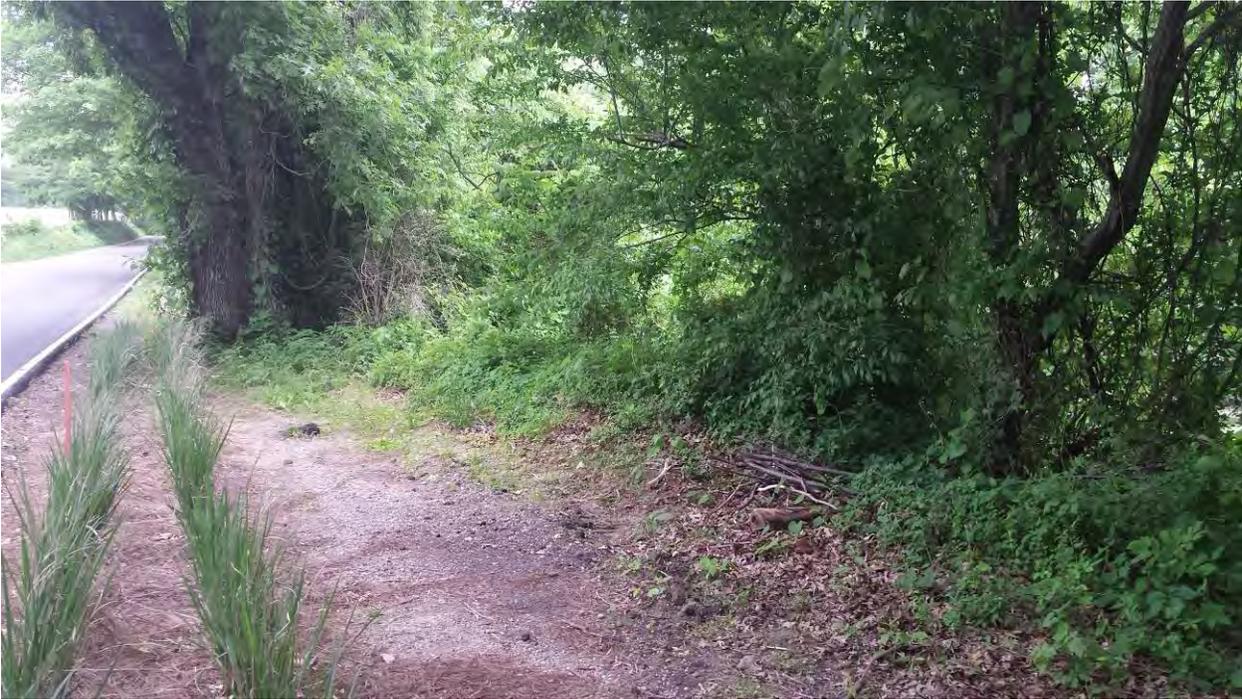
Description:	View of the bank of VSA Site 4, Harpeth River at Old Natchez Trace and Lawrence Roads. Note sheet flow runoff adjacent properties and proximity of the edge of pavement to bank edge. It appears as if some vegetation was planted here recently.
---------------------	---

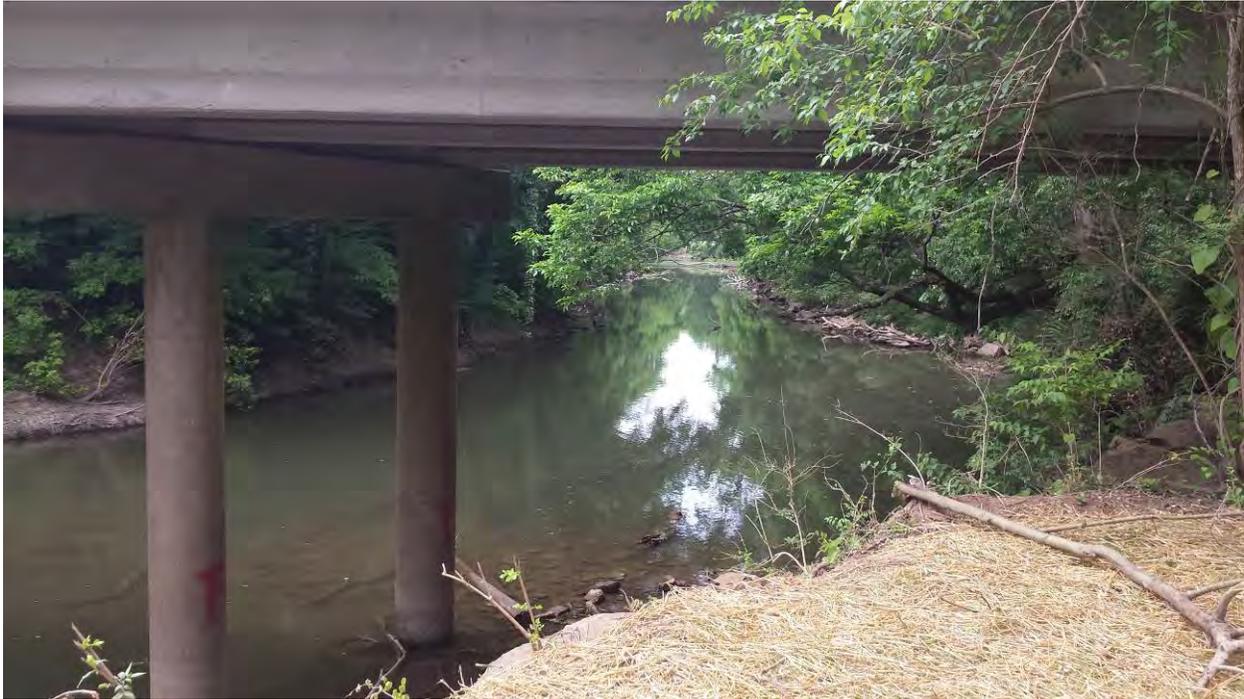
Description:	View of VSA Site 5, Harpeth River at Cotton Lane with steep banks and inadequate buffer. Note a recently cleared area that has been covered with hay.
---------------------	---

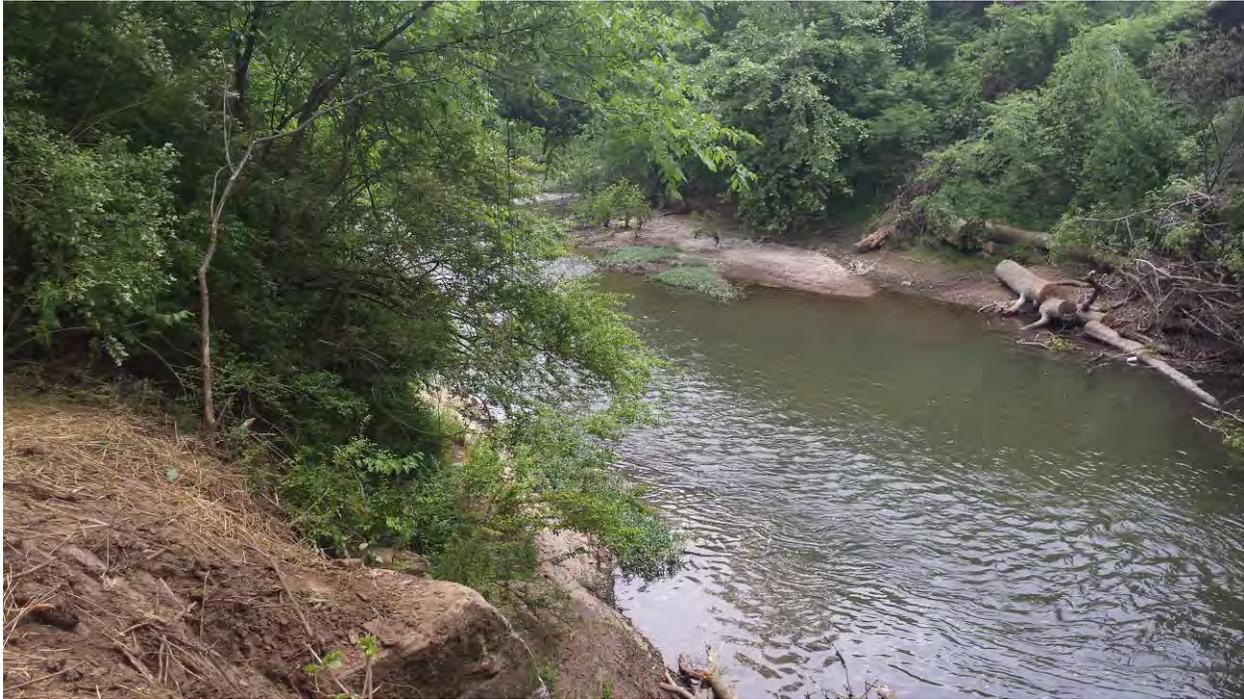
Description:	Additional view of VSA Site 5, Harpeth River at Cotton Lane with steep banks and inadequate buffer.
---------------------	---

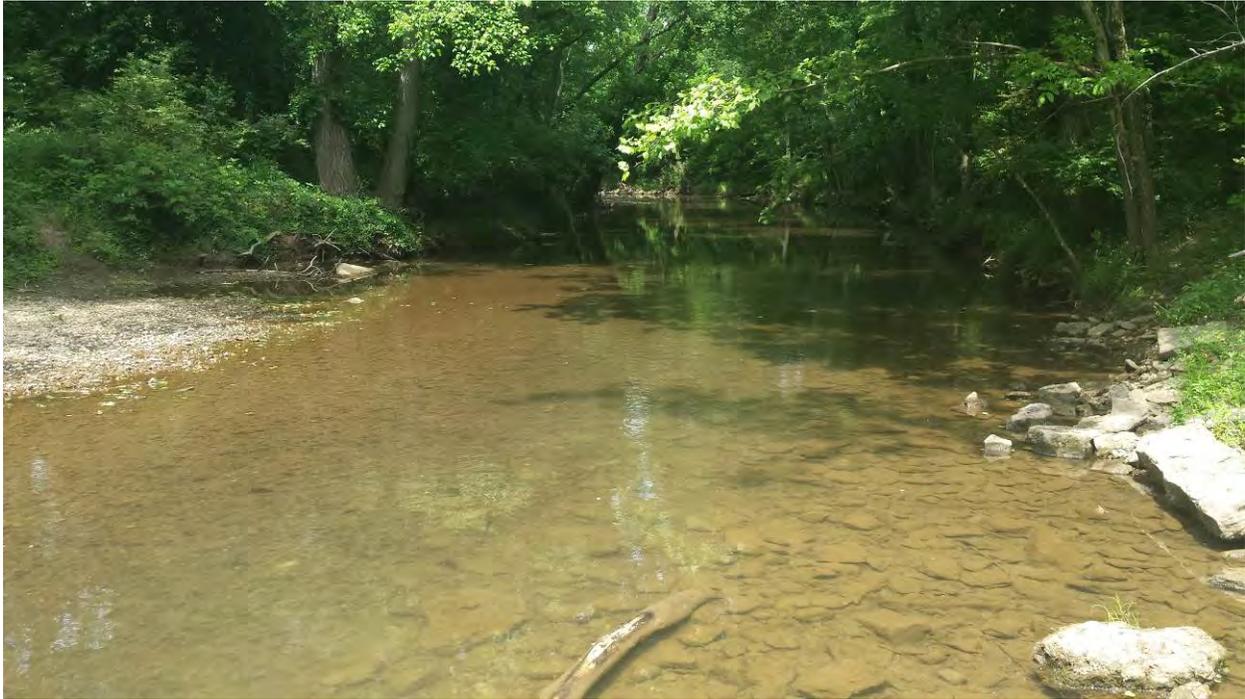
Description:	View of VSA Site 6, Little Harpeth River at Vaughn Road, a representative site. Note the sediment deposition on the creek bed.
---------------------	--

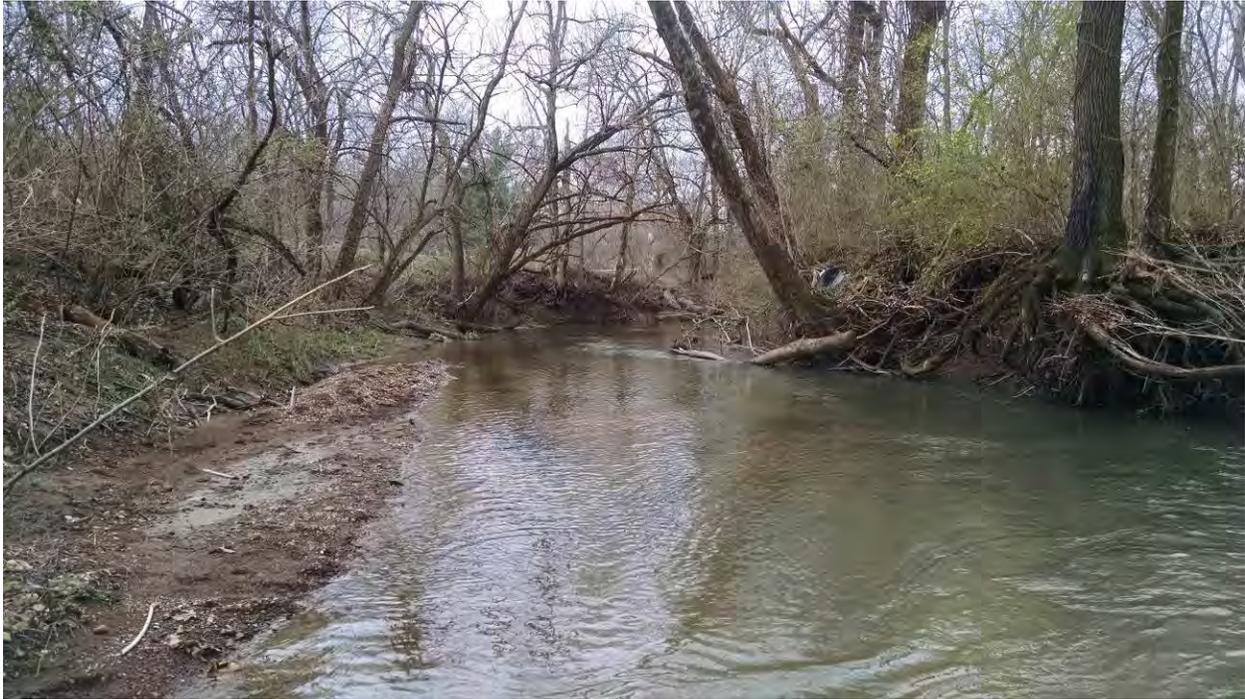
Description:	View of VSA Site 7, Rutherford Creek at Smithson Road showing high flow bank erosion and sediment bars, facing southwest.
---------------------	---

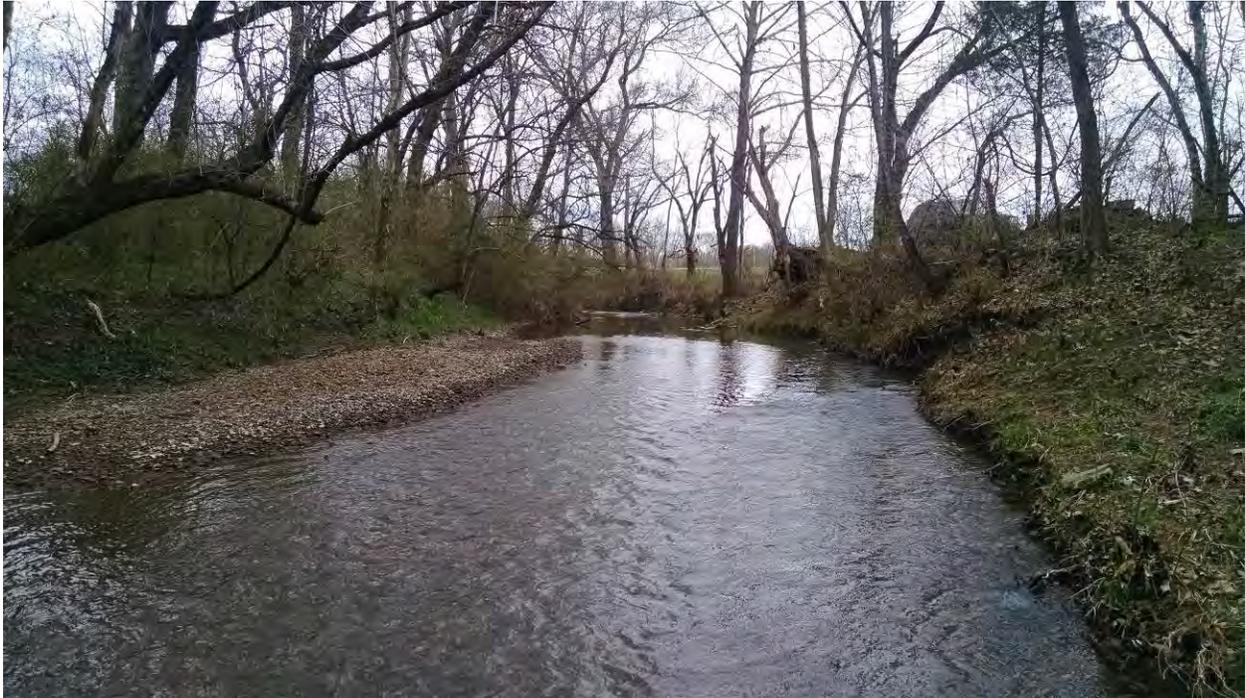
Description:	View of VSA Site 7, Rutherford Creek at Smithson Road showing bank under cutting and gravel bars, facing northeast.
---------------------	---

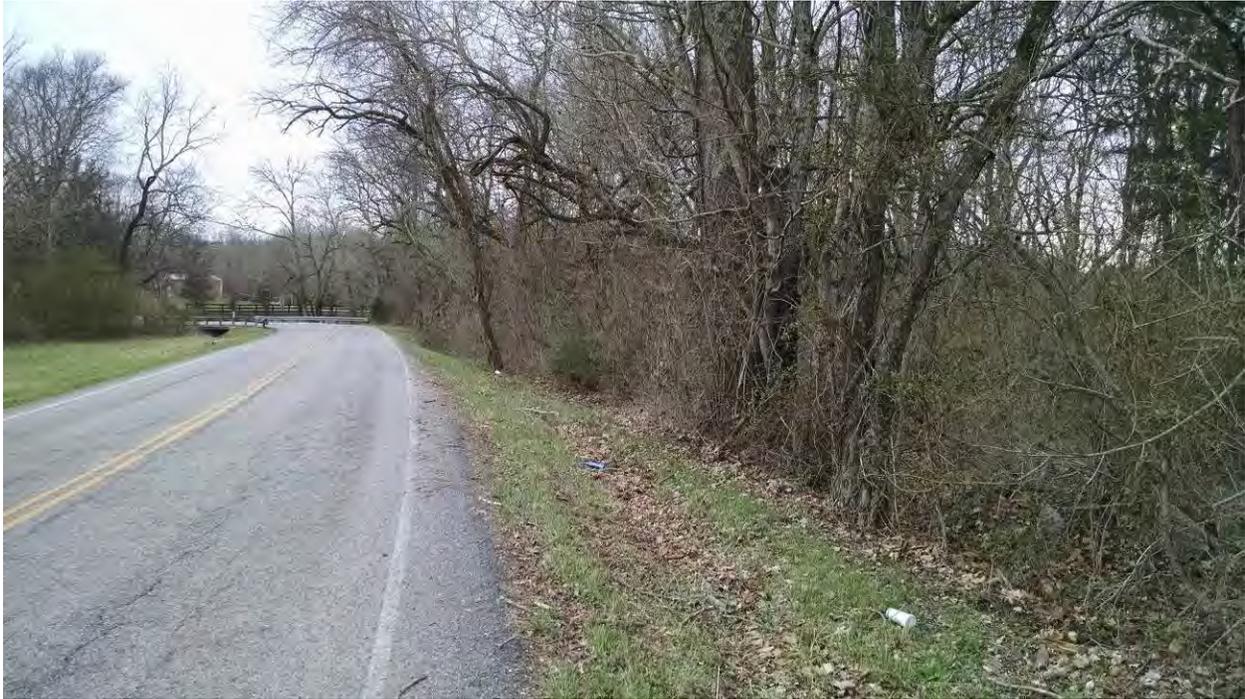
Description:	View of VSA Site 7, Rutherford Creek at Smithson Road showing the proximity of the edge of pavement and edge of creek bank. Photograph taken facing south.
---------------------	--

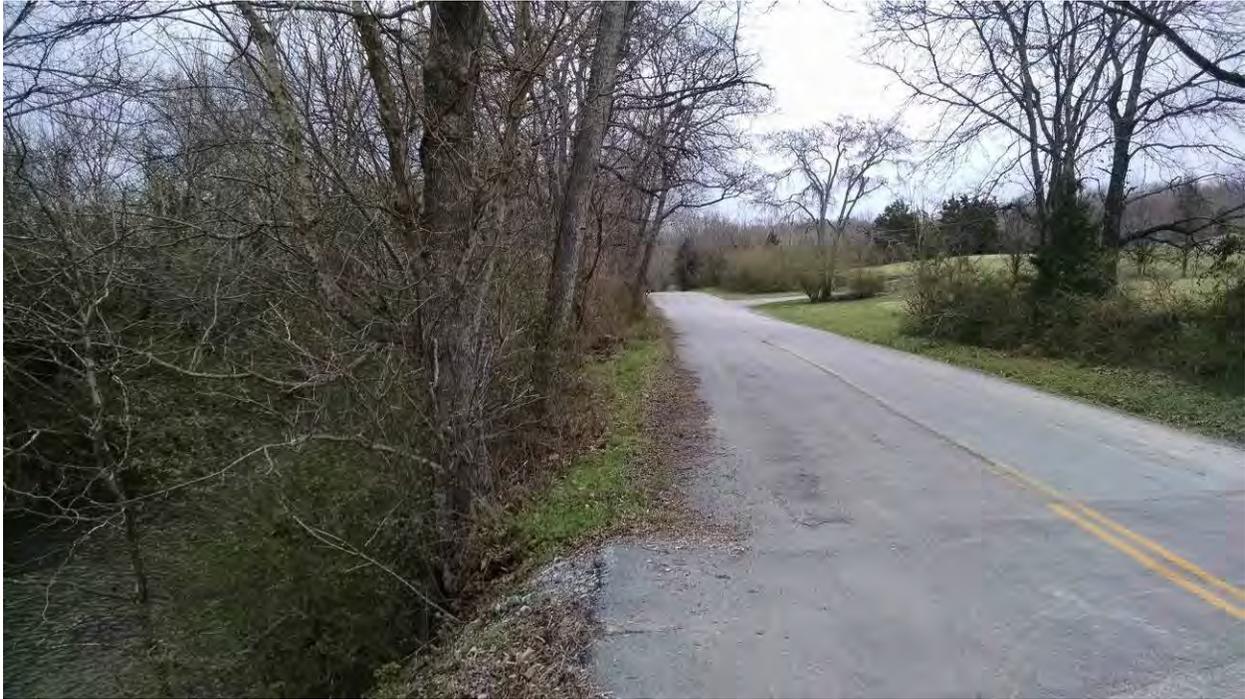
Description:	View of VSA Site 8, Rutherford Creek at Old Bethesda-Duplex Road indicating proximity of road surface and edge of creek bank. Photograph taken facing northeast.
---------------------	--

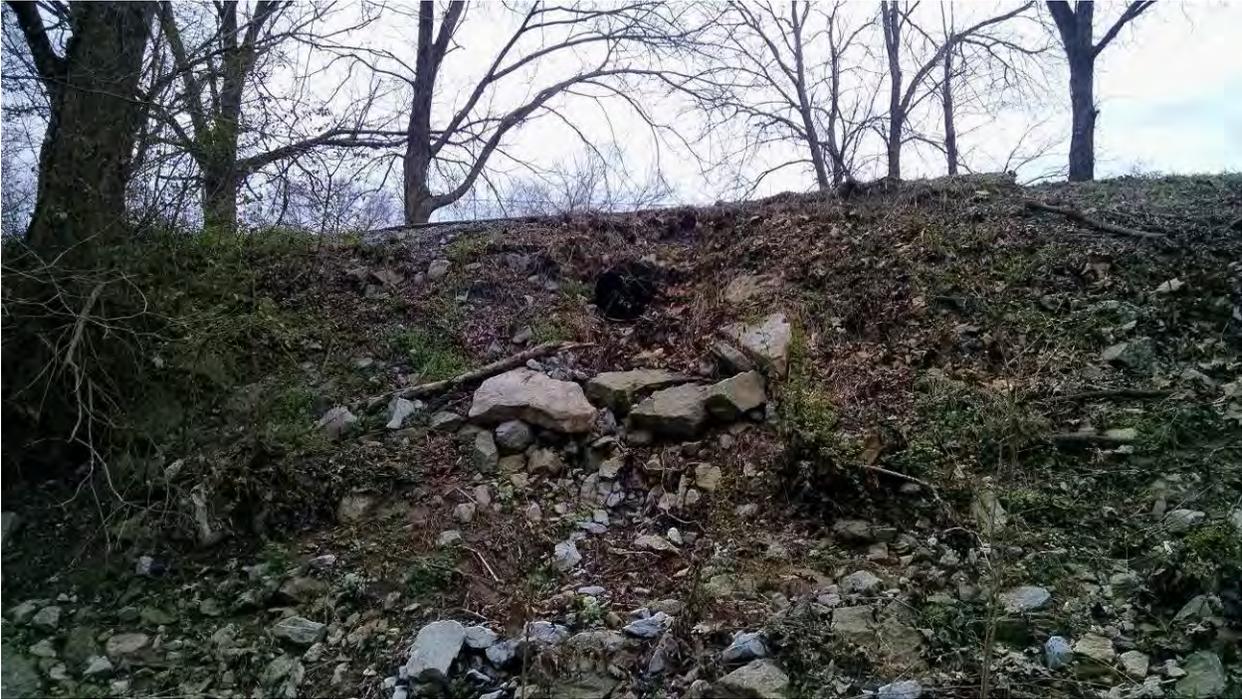
Description:	View of VSA Site 8, Rutherford Creek at Old Bethesda-Duplex Road illustrating corrugated metal stormwater pipe eroding steep creek bank.
---------------------	--

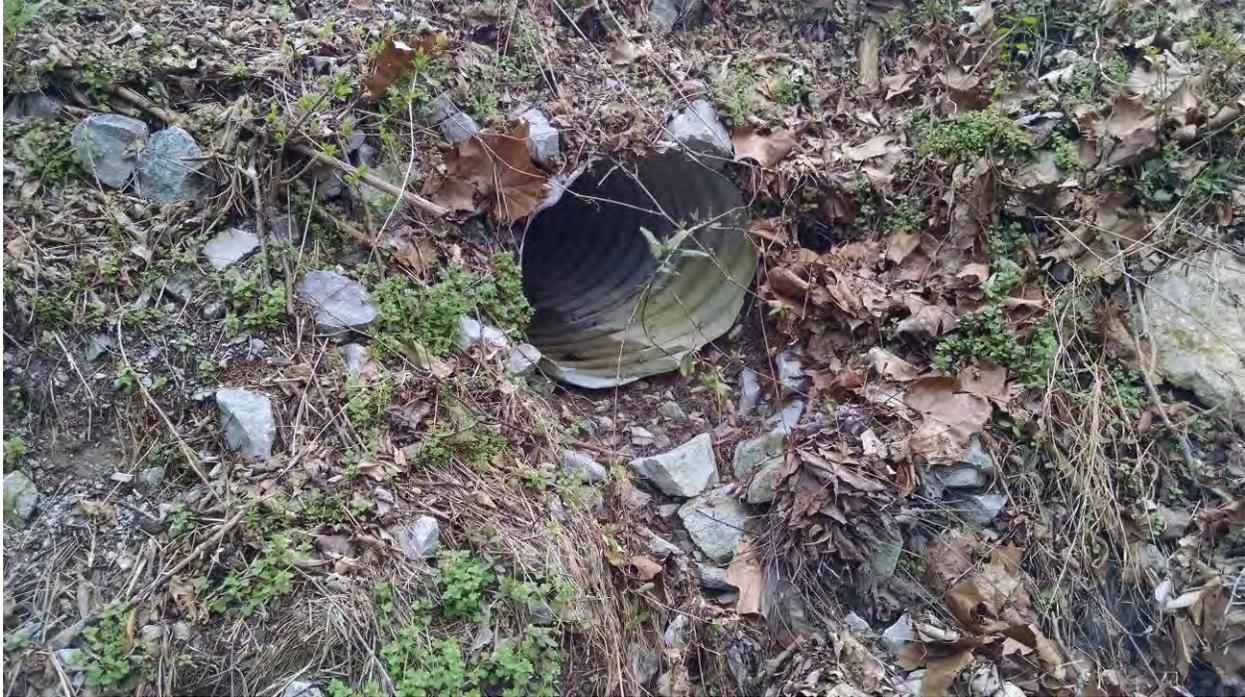
Description:	Additional view of the stormwater pipe at VSA Site 8, Rutherford Creek at Old Bethesda-Duplex Road.
---------------------	---
