**2014 / 2015 STREAM MONITORING REPORT
WILLIAMSON COUNTY, TENNESSEE
TETRA TECH PROJECT NO. 103S3287**

Williamson County Engineering Department
1320 West Main Street #400
Franklin, TN 37064
Attn: Mr. Michael Scott

September 23, 2015

Tetra Tech, Inc.
712 Melrose Avenue
Nashville, Tennessee 37211

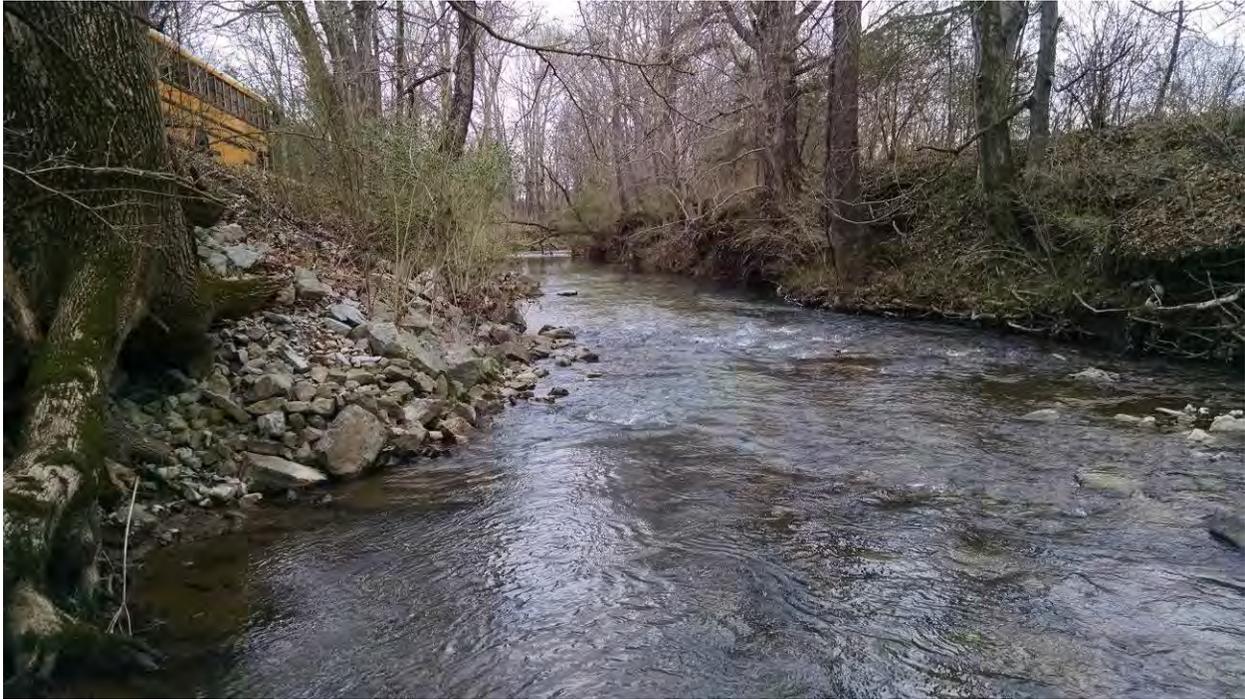
Description:	View of VSA Site 9, Rutherford Creek at Old Bethesda-Duplex Road documenting the edge of road surface to creek bed. Photograph taken facing southwest.
---------------------	--

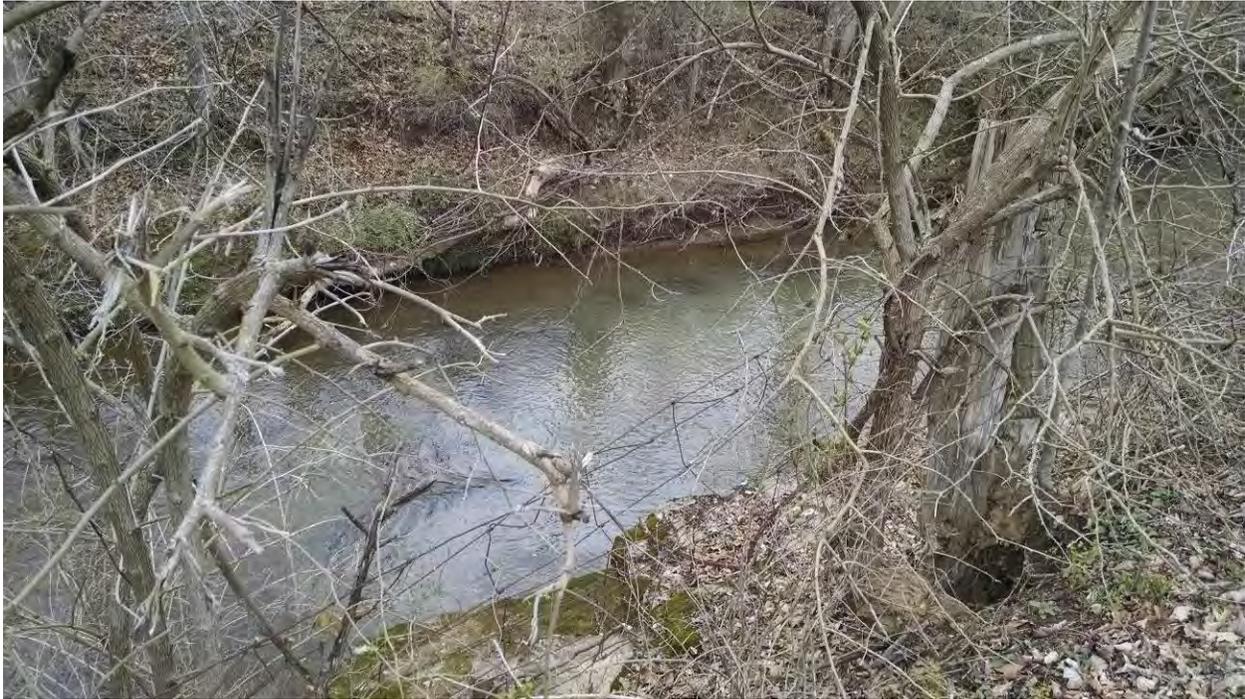
Description:	View of VSA Site 9, Rutherford Creek and proximity of road surface to creek bank, facing north.
---------------------	---

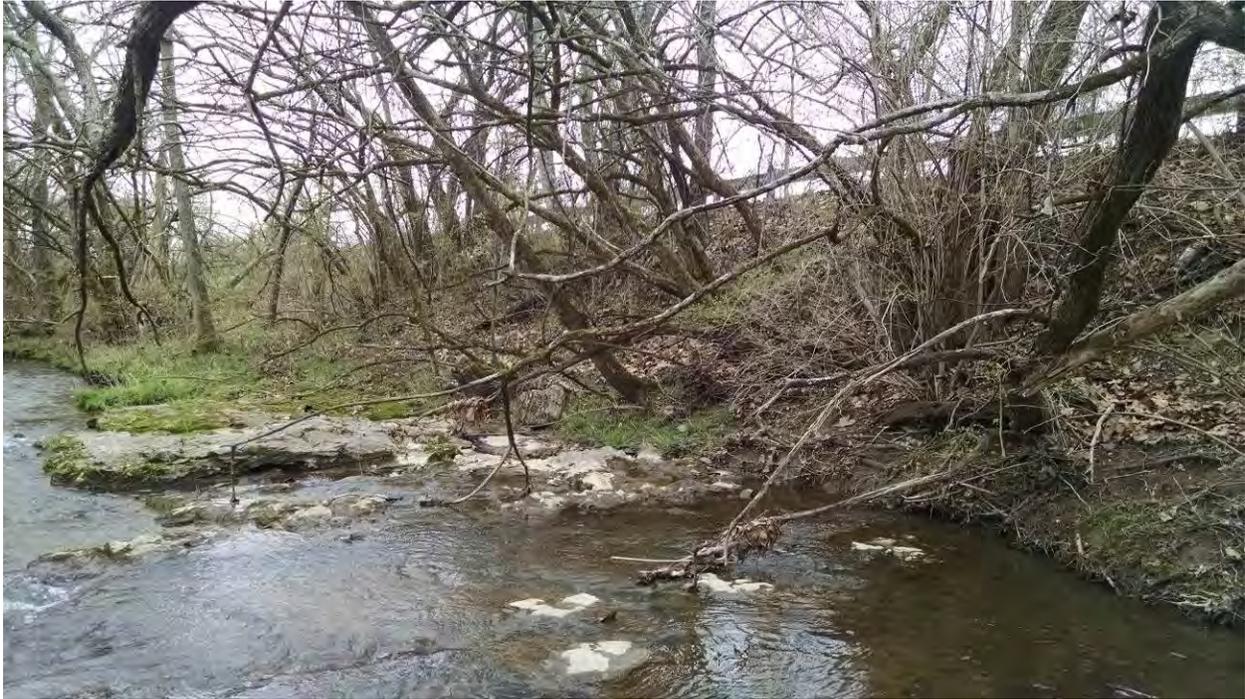
Description:	View of VSA Site 10, Rutherford Creek at Bethesda-Duplex Road, facing northeast. Note the proximity of the road surface to the creek bank.
---------------------	--

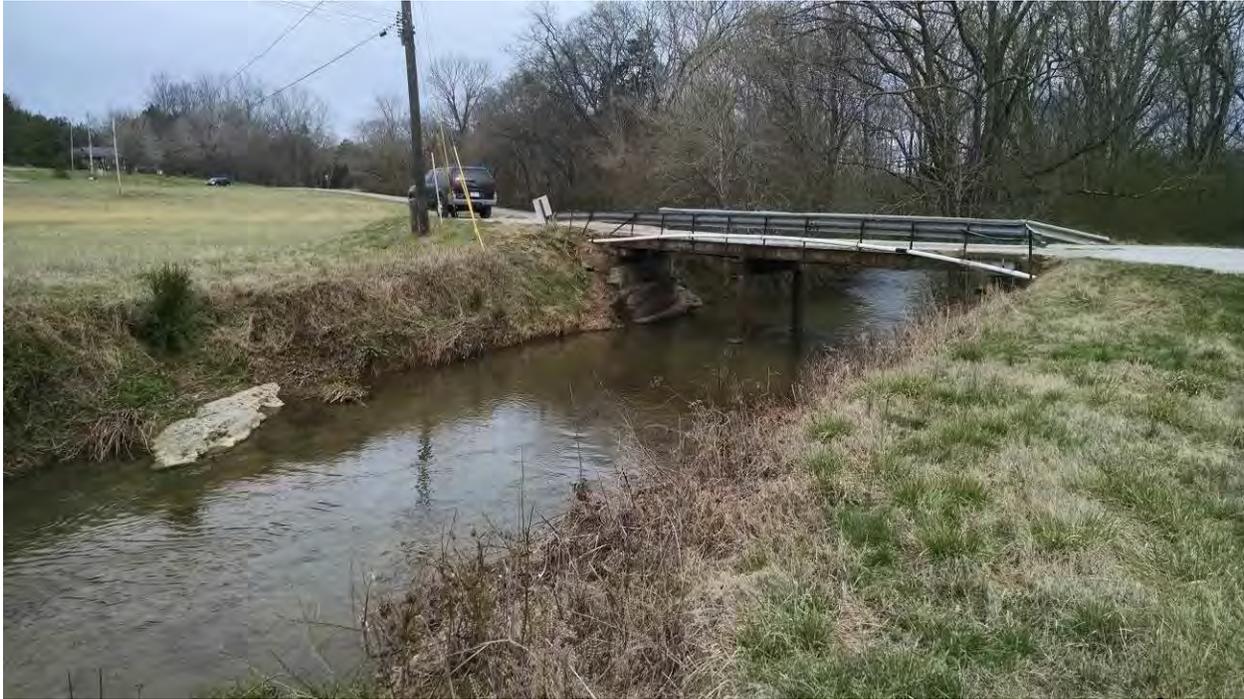
Description:	View of VSA Site 11, Rutherford Creek at Mosley Road, facing west and showing steep vegetated creek banks and bridge abutment erosion.
---------------------	--

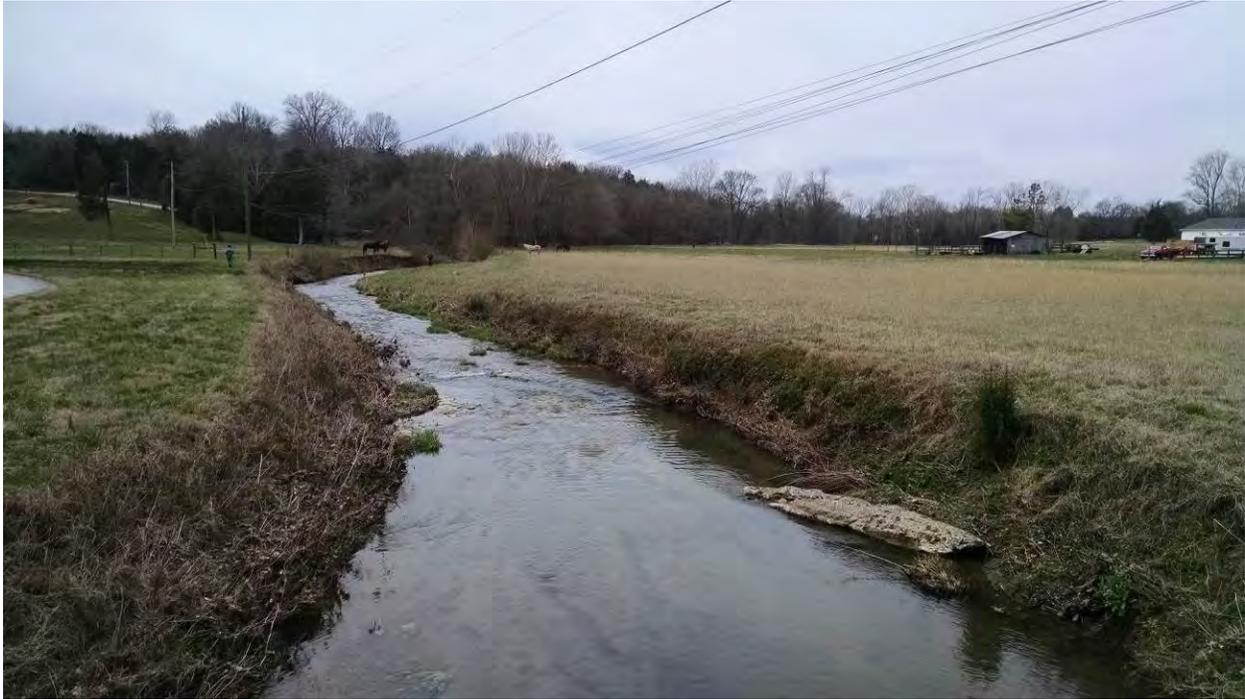
Description:

View of VSA Site 11, Rutherford Creek at Mosley Road and surrounding agricultural operation facing east.

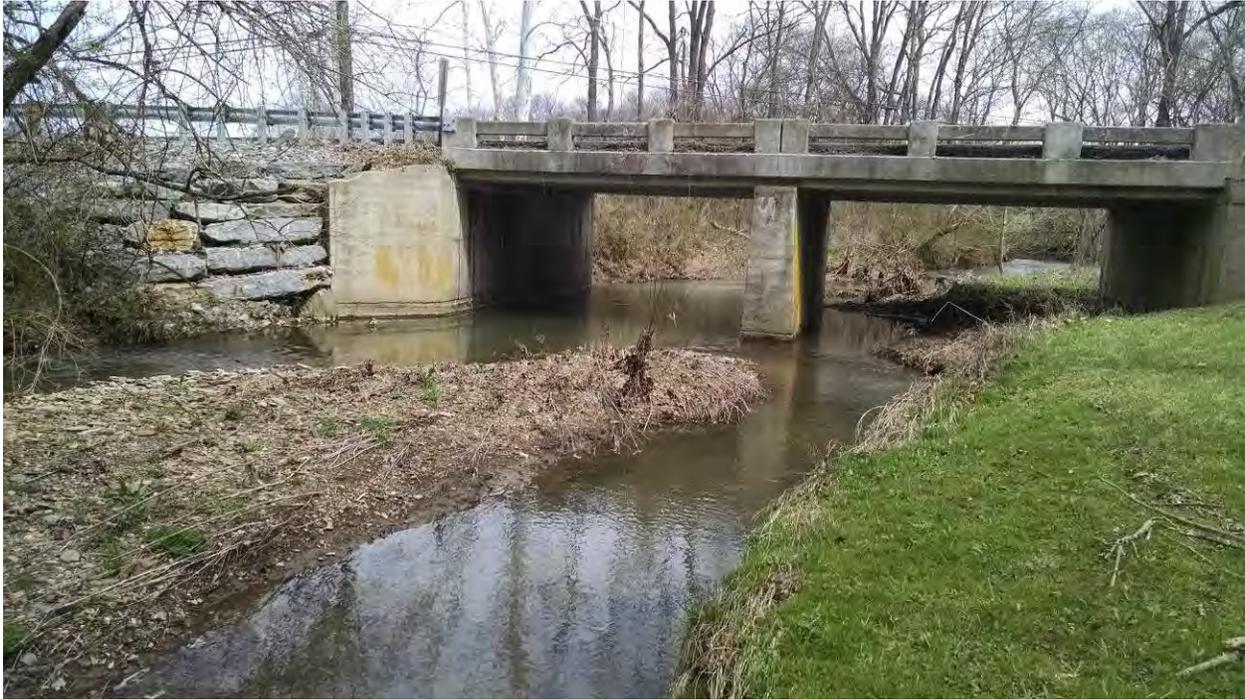
Description:	View of VSA Site 12, Rutherford Creek at Cross Keys Road with steep creek banks and bridge erosion and sediment deposition. The photograph was taken facing east.
---------------------	---

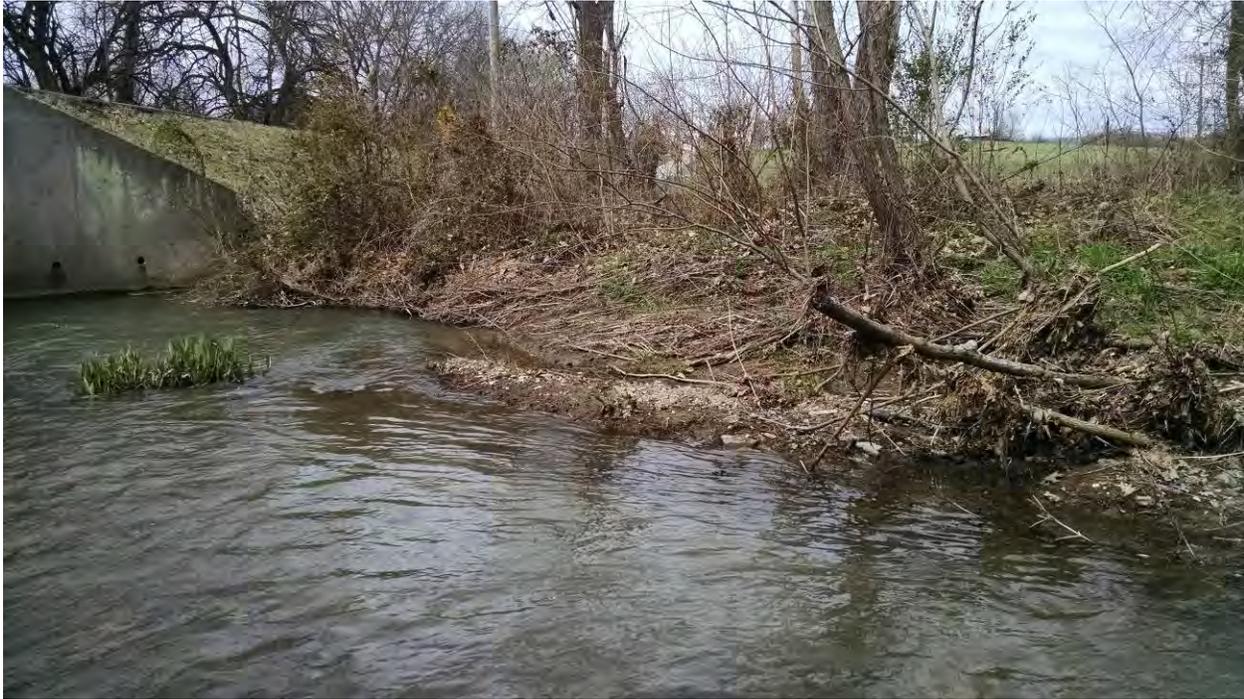
Description:	Additional view of VSA Site 12, Rutherford Creek at Cross Keys Road showing debris washed up on the bank. Photograph taken facing northwest.
---------------------	--

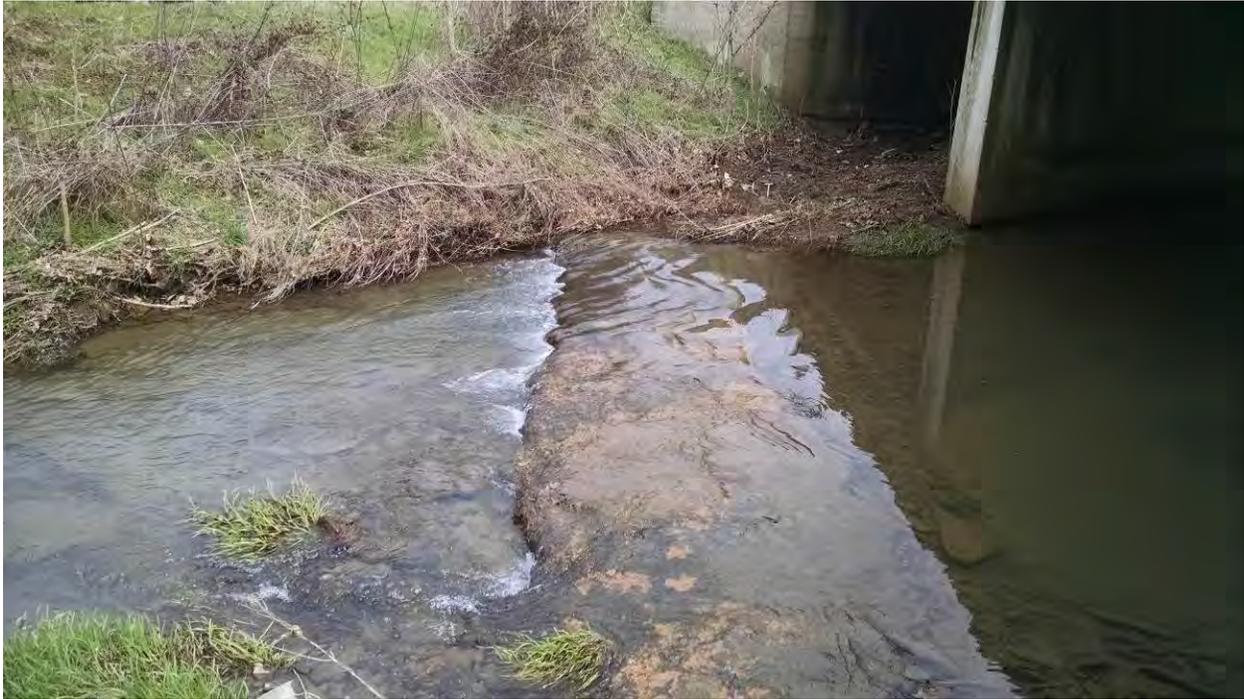
Description:	View of VSA Site 13, Rutherford Creek at Cross Keys/ Comstock Road documenting natural or manmade fish barrier. Photograph taken facing east.
---------------------	---

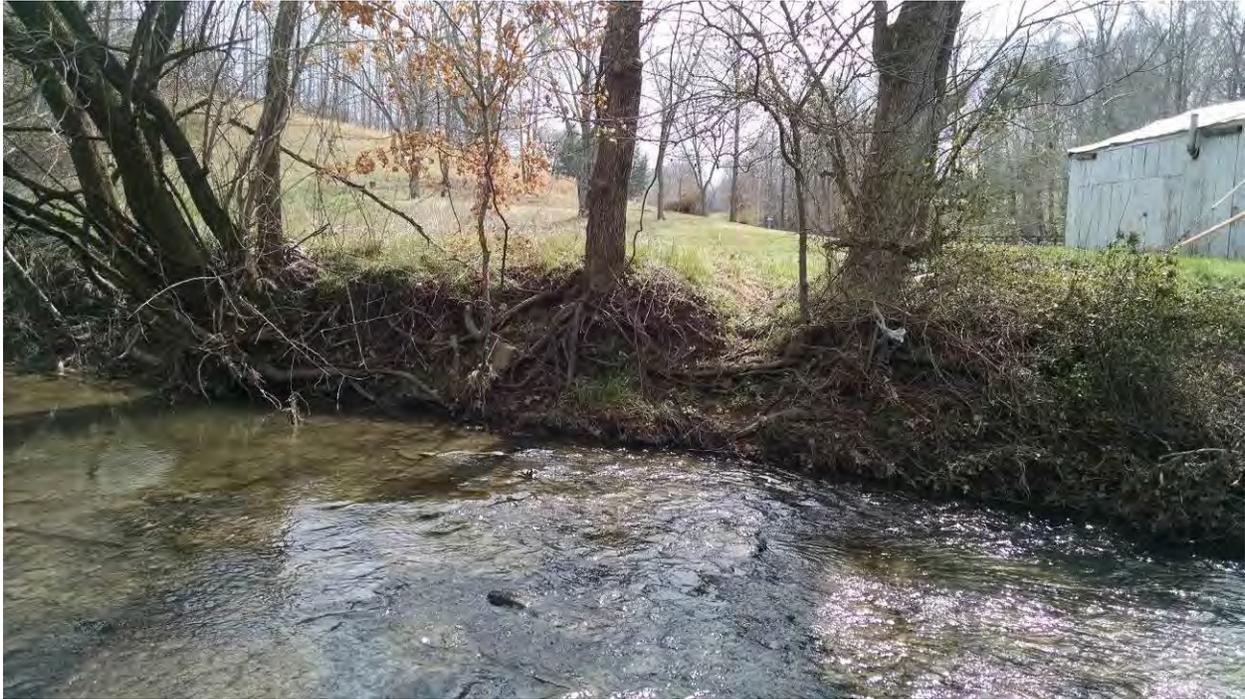
Description:	View of VSA Site 13, Rutherford Creek at Cross Keys/ Comstock Road documenting bank erosion.
---------------------	--

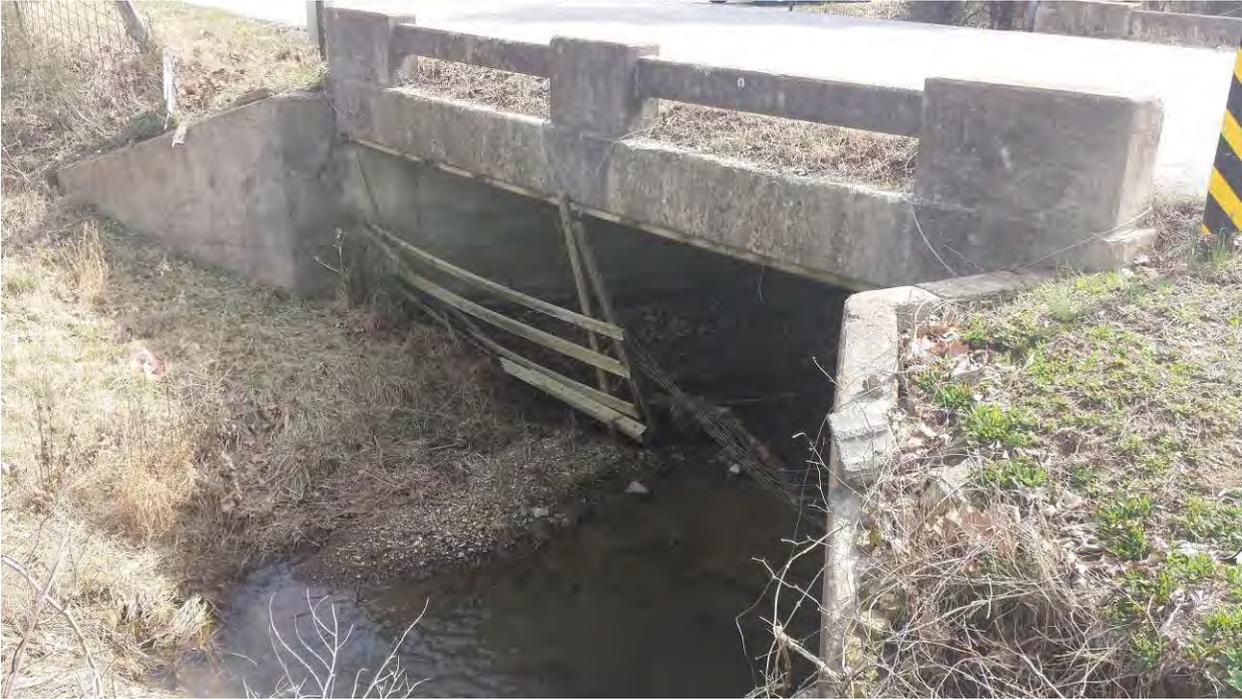
Description:	View of VSA Site 14, Rutherford Creek at Cross Keys Road documenting blockage with a cattle gate.
---------------------	---

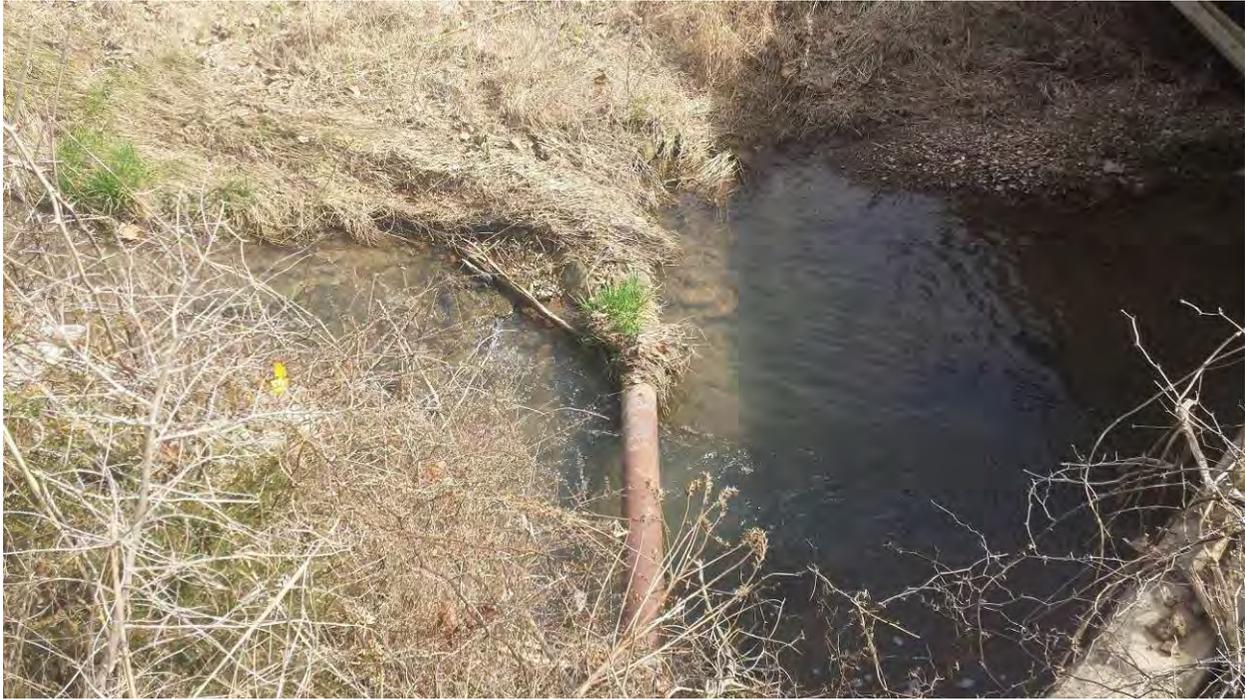
Description:	View of VSA Site 14, showing an iron pipe crossing the stream corridor.
---------------------	---

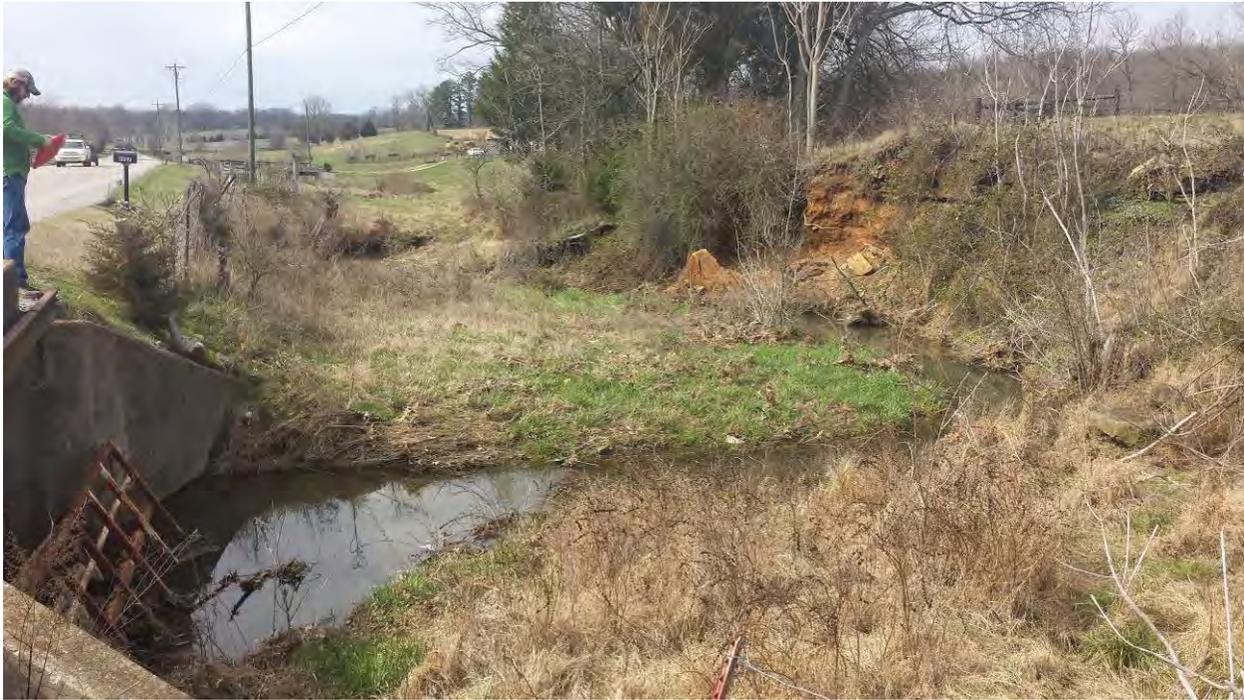
Description:	View of VSA Site 15, Rutherford Creek at Cross Keys Road showing blockage with a cattle gate. Note the bank failure in the background of the photo. Photograph taken on the northern side of the road facing northwest.
---------------------	---

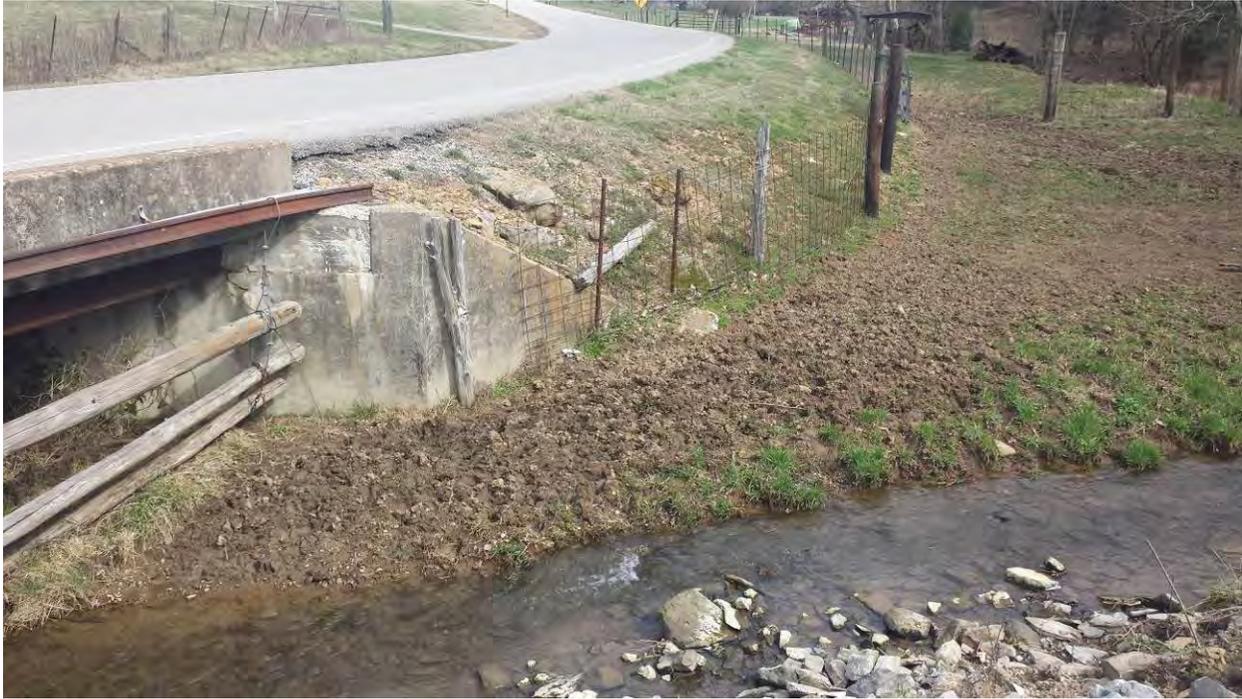
Description:

View of VSA Site 15 showing a cattle gate on the southern side of the bridge and evidence of cattle presence in the creek. Photograph taken facing northwest along Cross Keys Road.

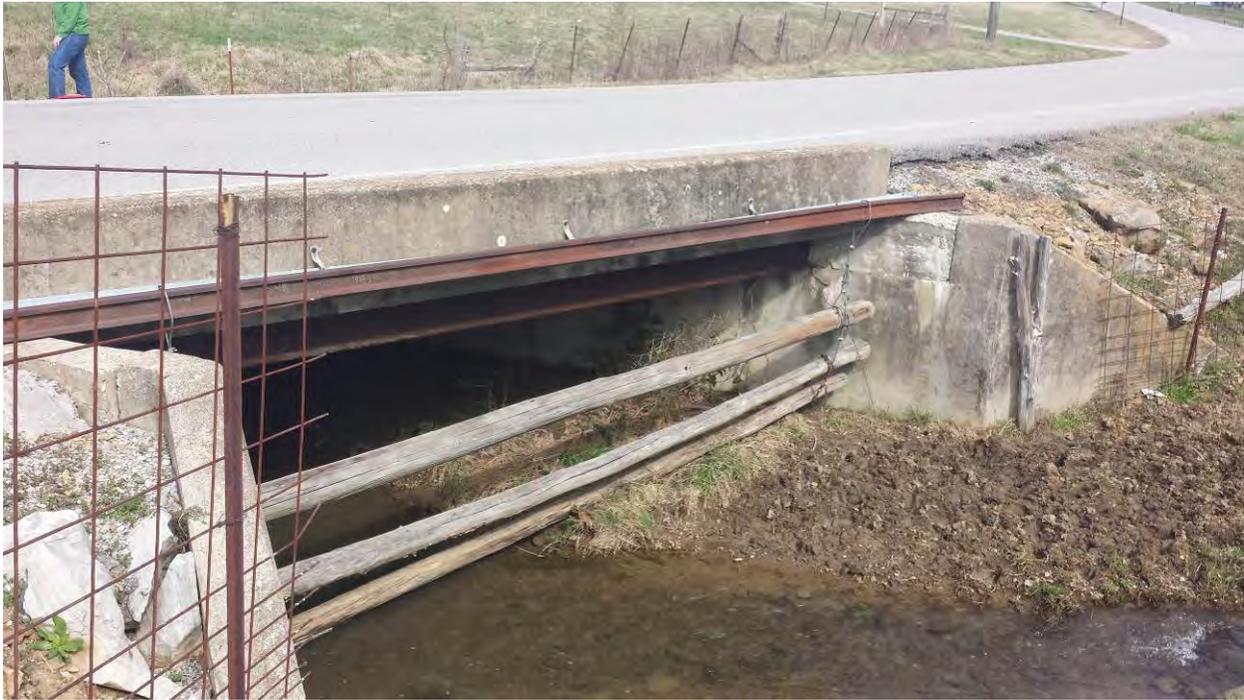
Description:	Additional view of the cattle gate at VSA Site 15, facing northwest.
---------------------	--

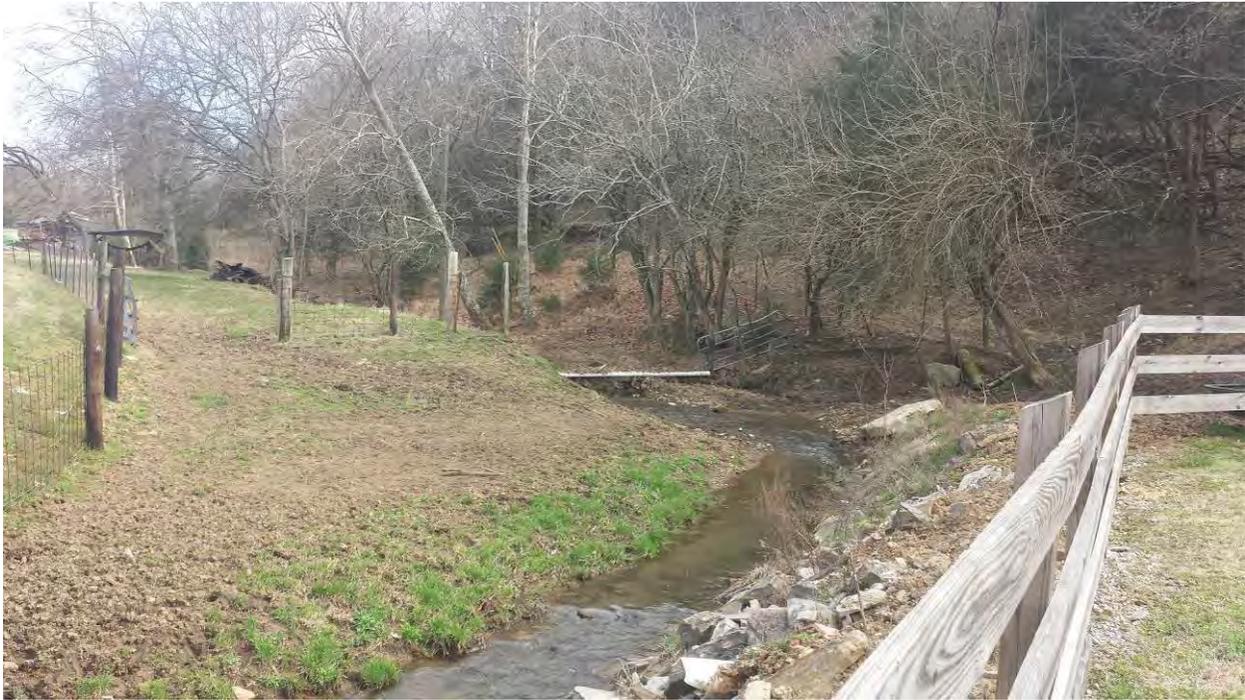
Description:	View of VSA Site 15, to the south showing another cattle gate across the creek and evidence of cattle in the creek.
---------------------	---

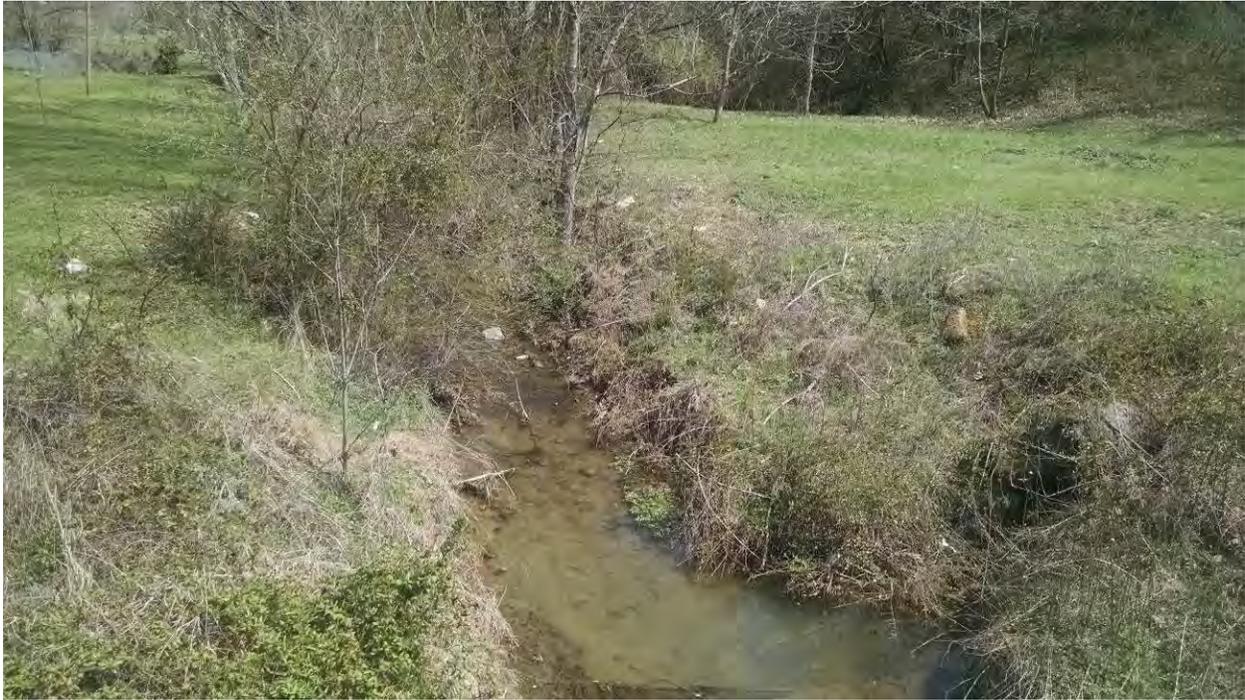
Description:	View of VSA Site 16, Rutherford Creek at Cross Keys Road showing the recessed stormwater outfall pipe. Photograph taken facing east.
---------------------	--

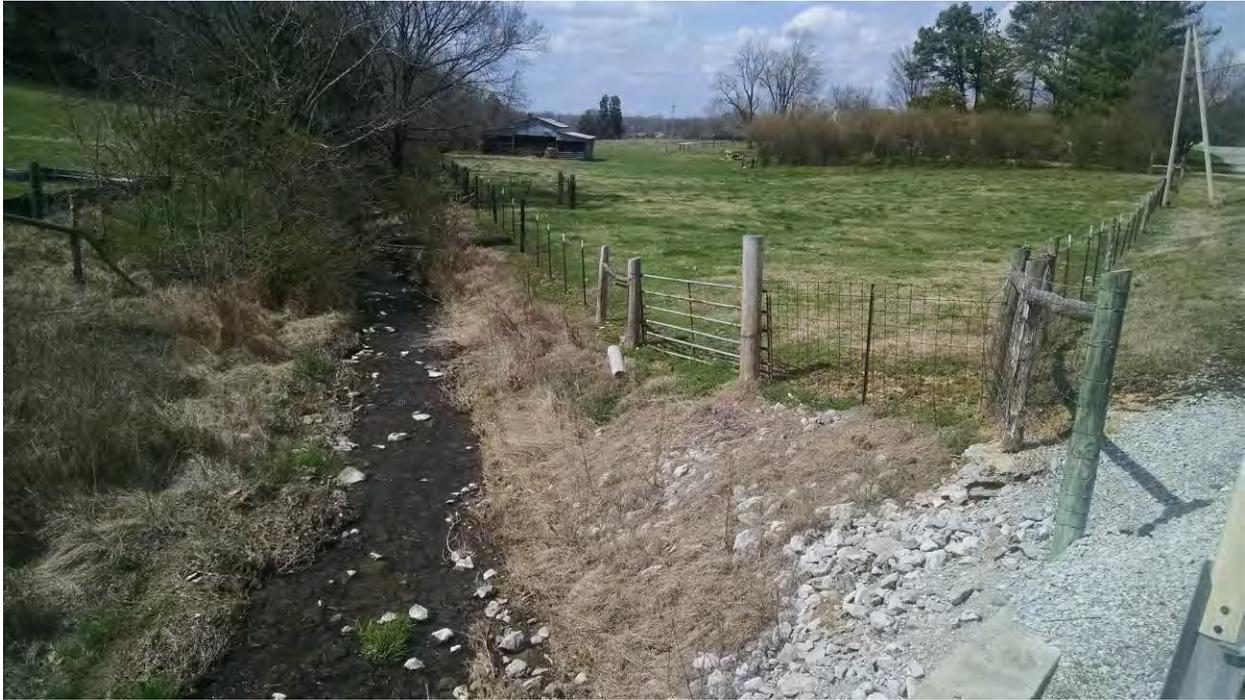
Description:	View of VSA Site 16, Rutherford Creek at Cross Keys Road facing west.
---------------------	---

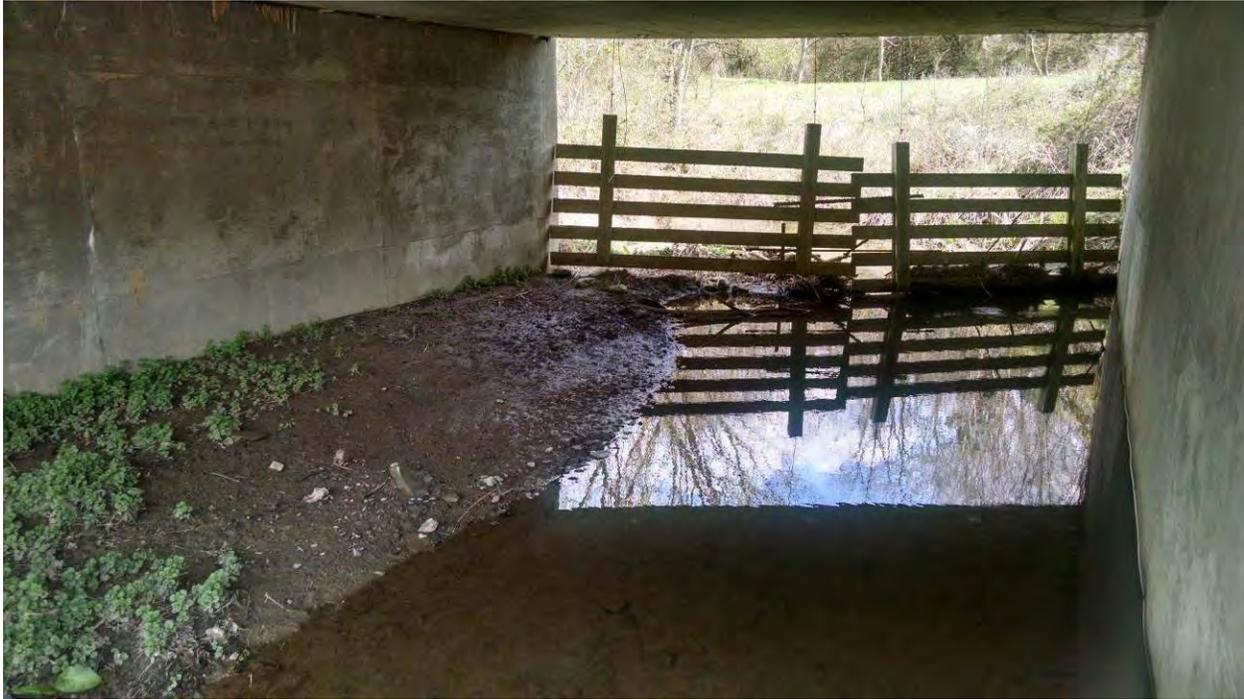
Description:	View of VSA Site 16, Rutherford Creek at Cross Keys Road showing the cattle gate beneath the road bridge.
---------------------	---

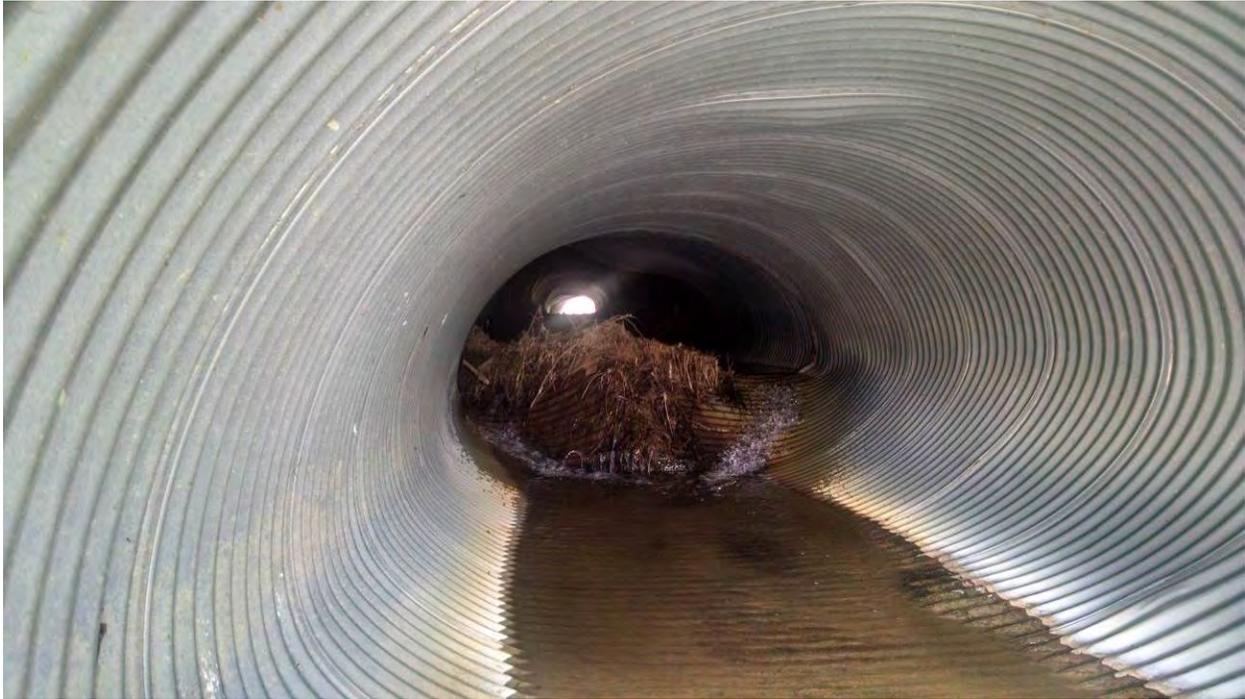
Description:	View of VSA Site 17, Rutherford Creek at Pulltight Hill Road, documenting channel alteration through a corrugated metal pipe, pipe damage, and debris blockage which is a fish barrier.
---------------------	---

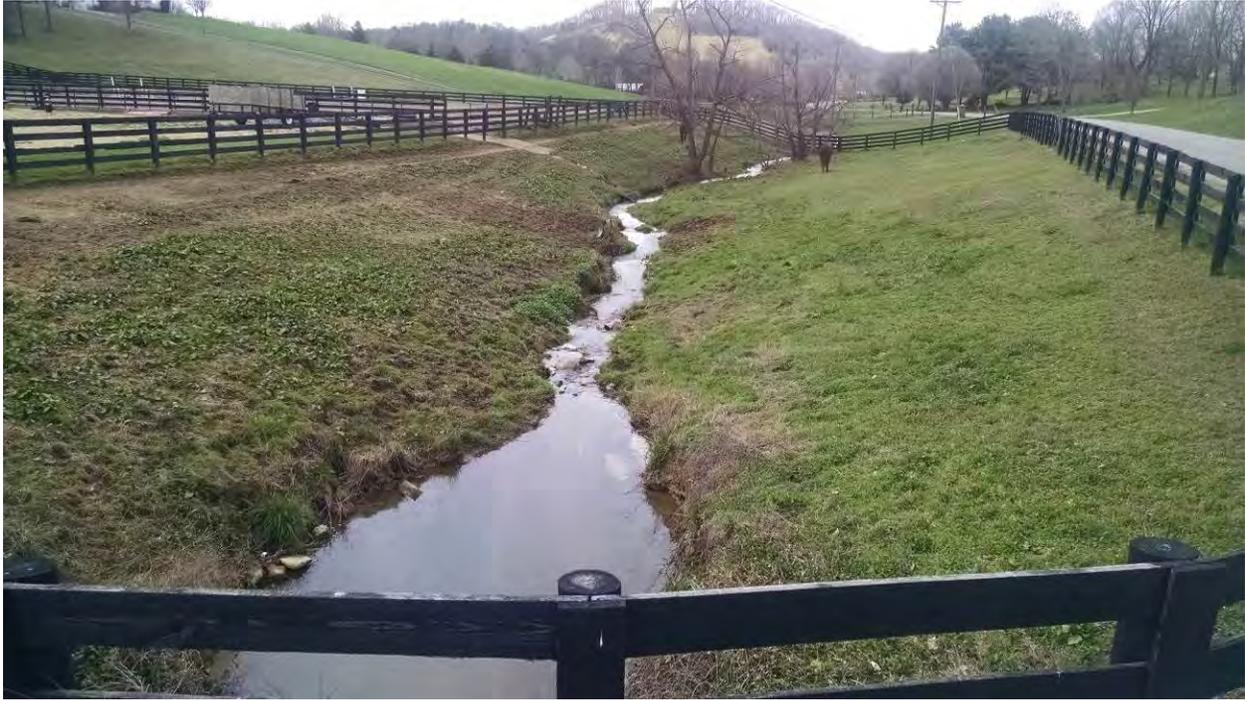
Description:	View of VSA Site 17, facing west, showing agricultural use.
---------------------	---

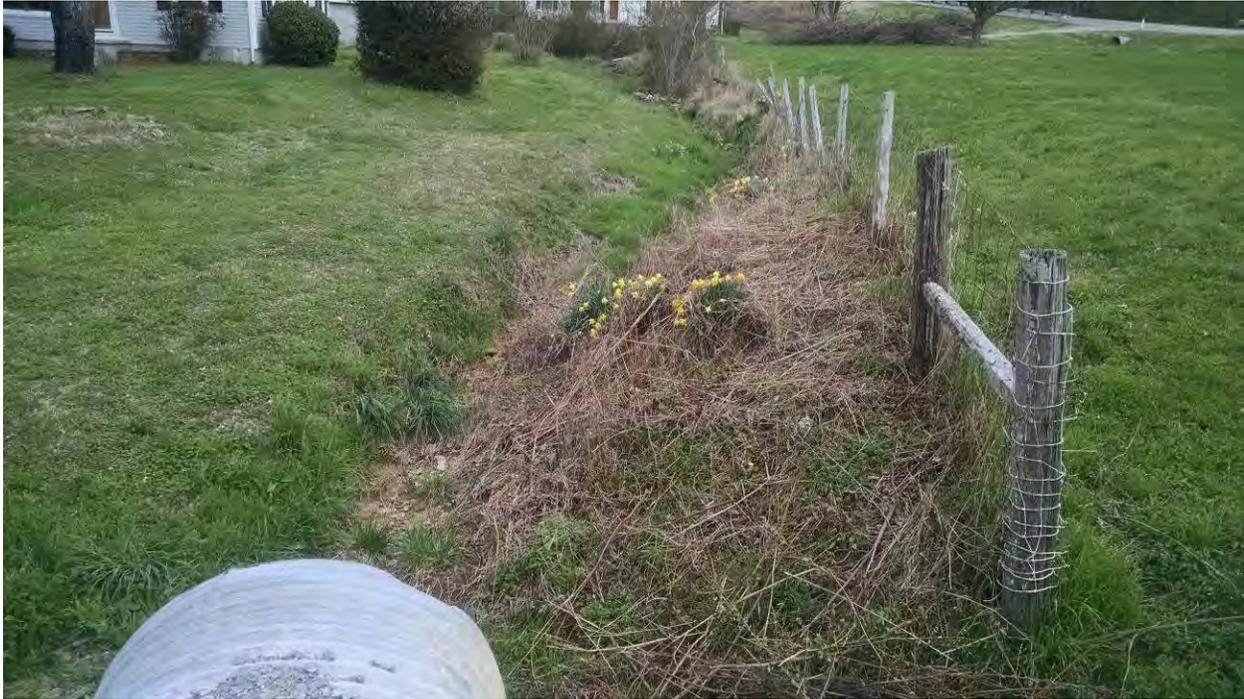
Description:	View of VSA Site 18, east of Mt. Zion Road showing the creek banks that appear to be mowed as a residential lawn. Note the corrugated metal pipe that acts as a road culvert.
---------------------	---

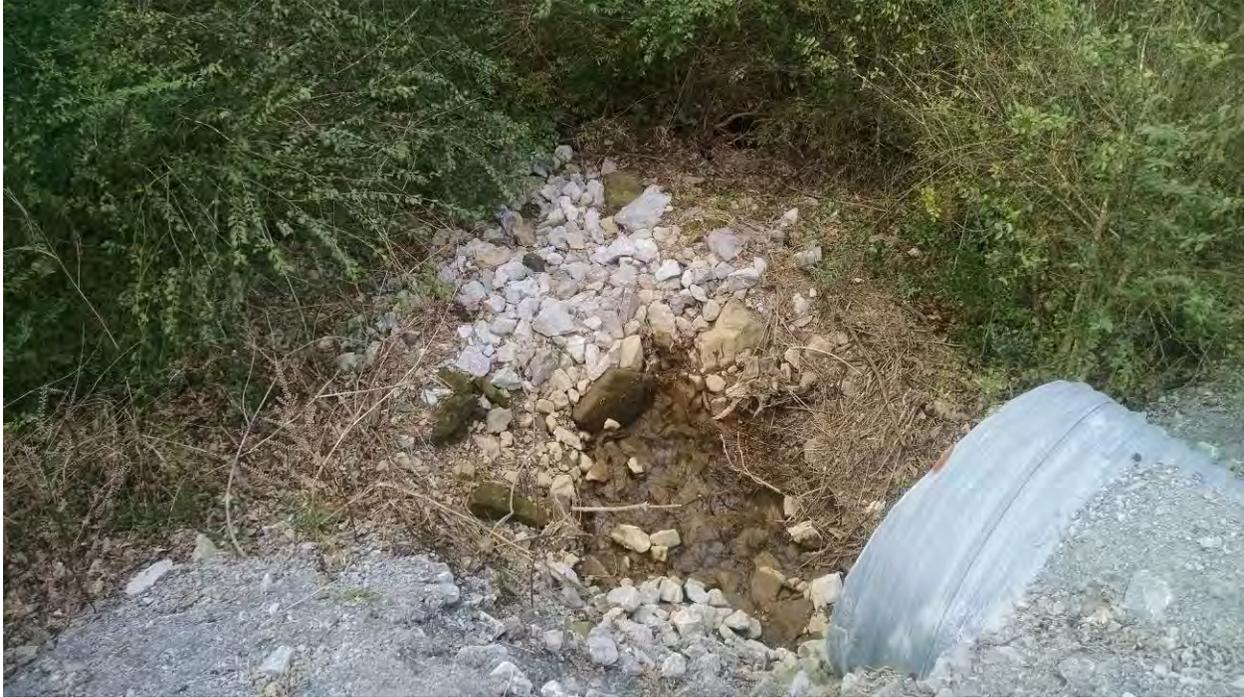
Description:

View of the corrugated metal pipe that acts a road culvert at VSA Site 18 on the west side of Mt. Zion Road. The creek bed has been blocked by rip rap below the pipe.

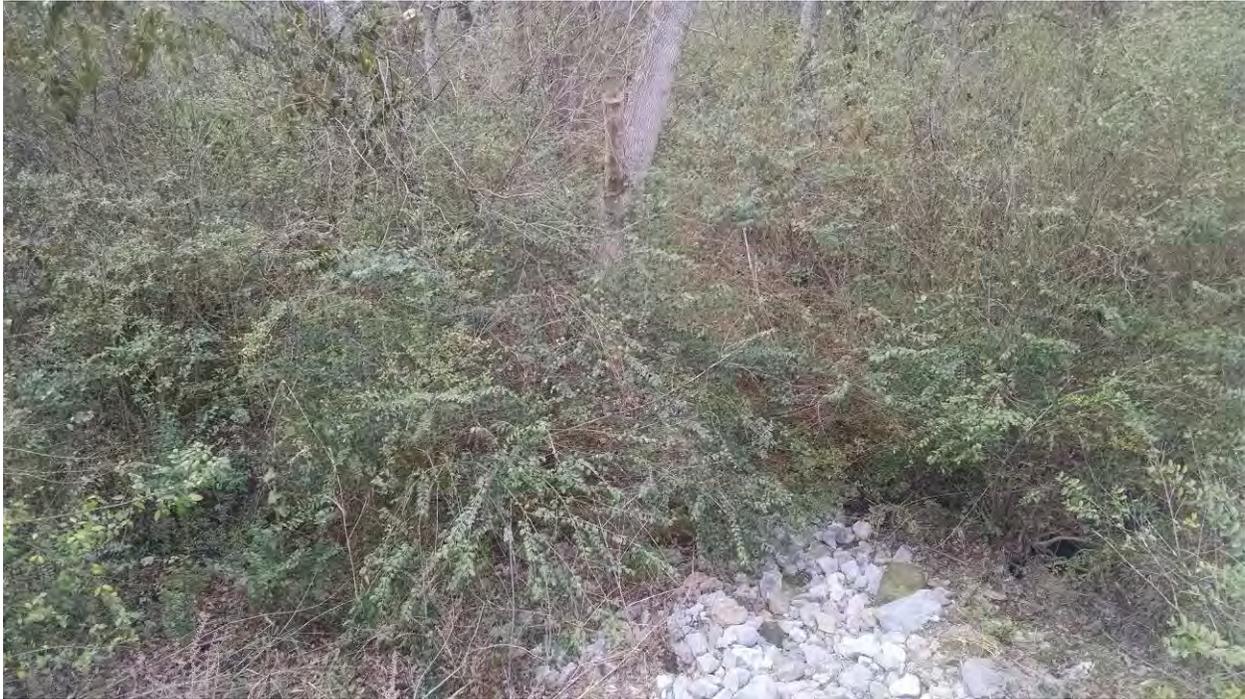
View of the creek channel to the west of Mt. Zion Road at VSA Site 18.

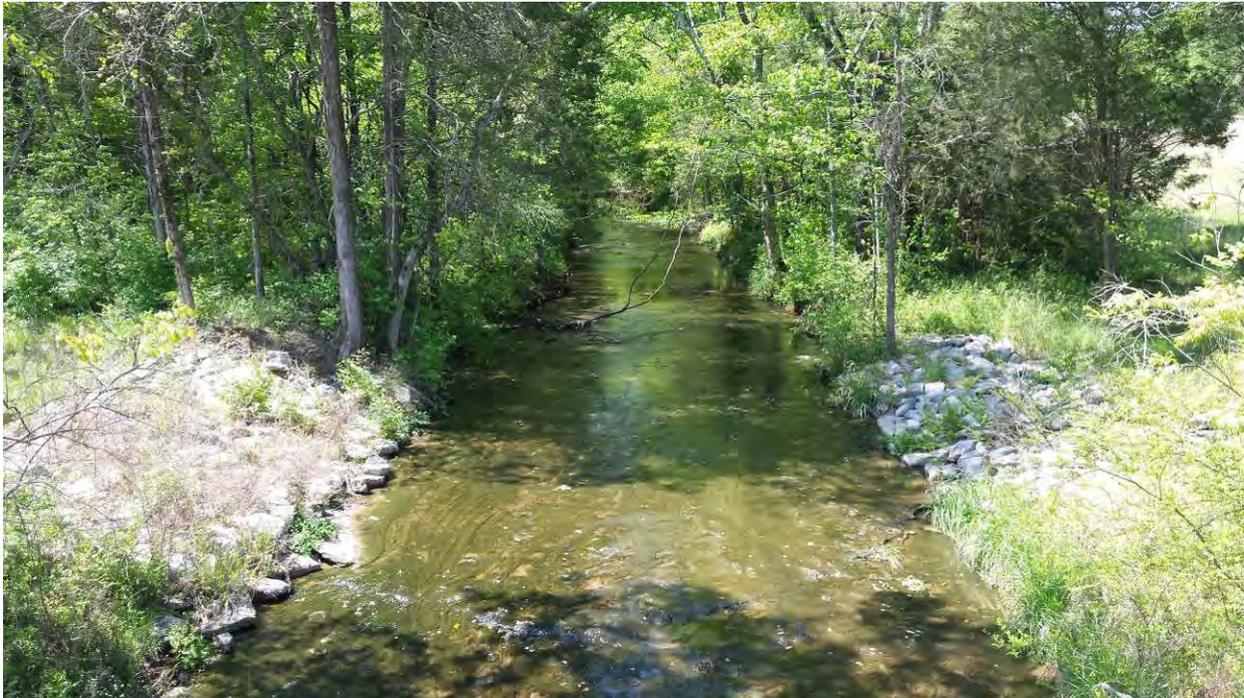
Description:	View of VSA Site 19, Owl Creek at Split Log Road. Excessive algae was observed in the stream reach.
---------------------	---

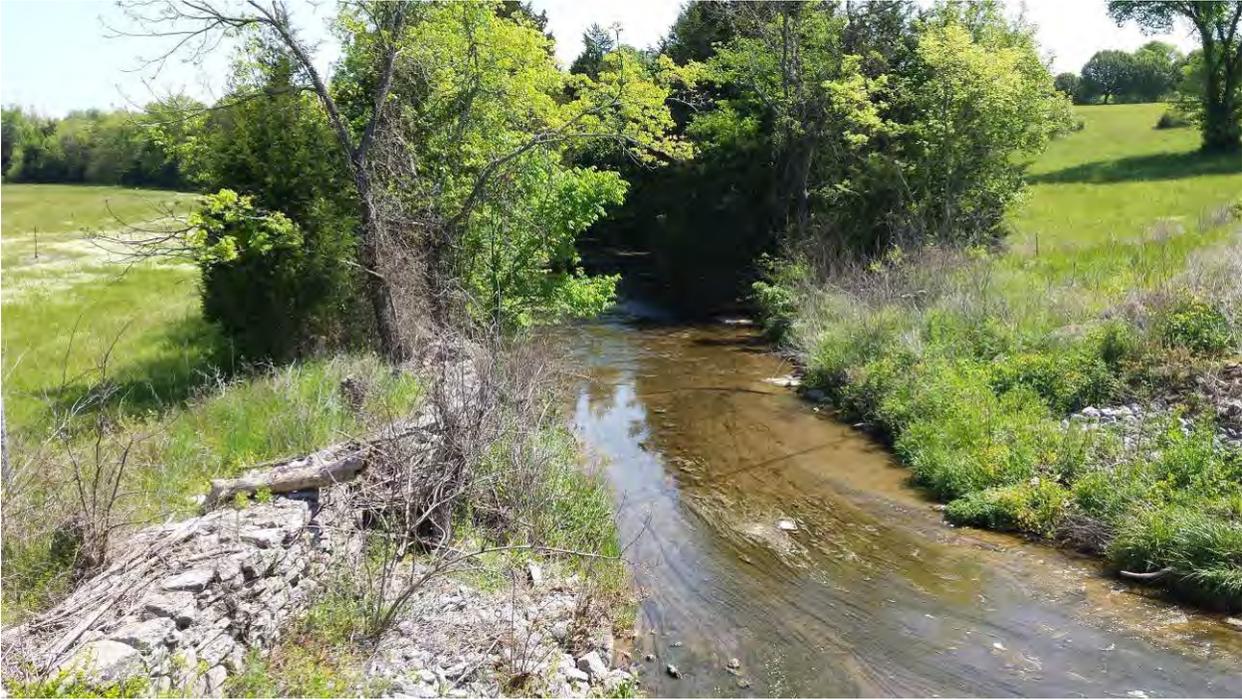
Description:	View of VSA Site 19, Owl Creek at Split Log Road showing inadequate riparian buffer and excessive vegetation in the creek.
---------------------	--
