**2014 / 2015 STREAM MONITORING REPORT
WILLIAMSON COUNTY, TENNESSEE
TETRA TECH PROJECT NO. 103S3287**

Williamson County Engineering Department
1320 West Main Street #400
Franklin, TN 37064
Attn: Mr. Michael Scott

September 23, 2015

Tetra Tech, Inc.
712 Melrose Avenue
Nashville, Tennessee 37211

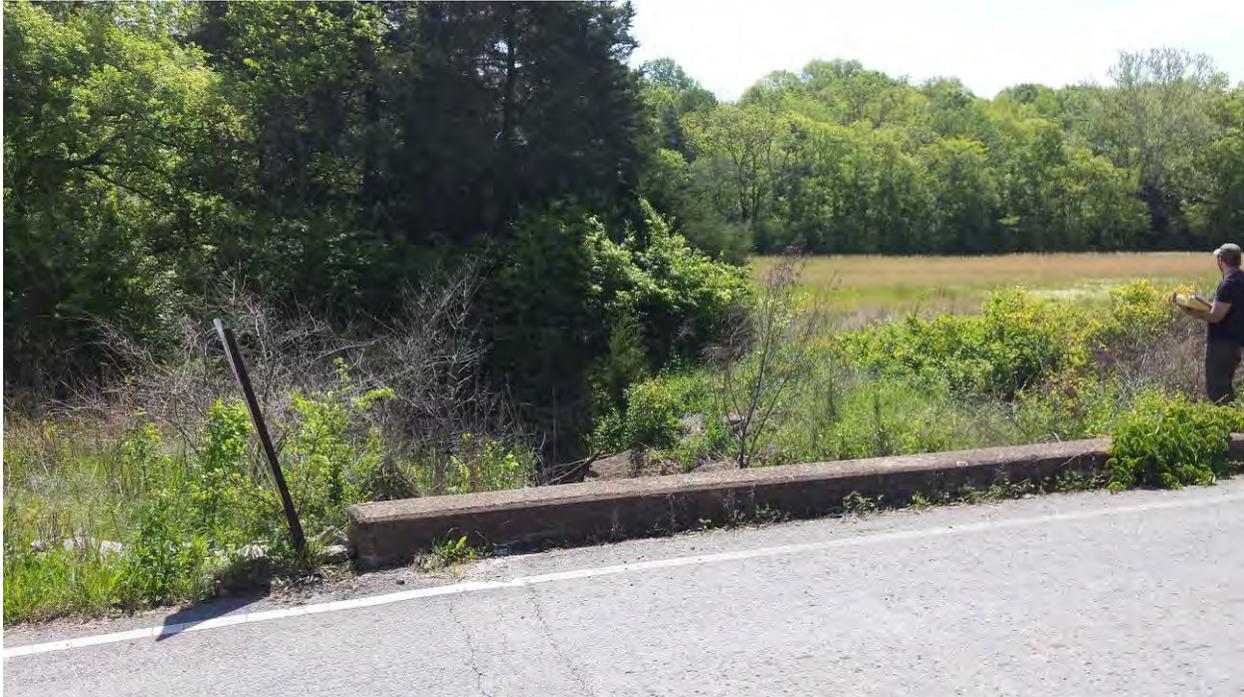
Description:	View of VSA Site 20, Owl Creek at Pleasant Hill Road and Split log Road, facing south.
---------------------	--

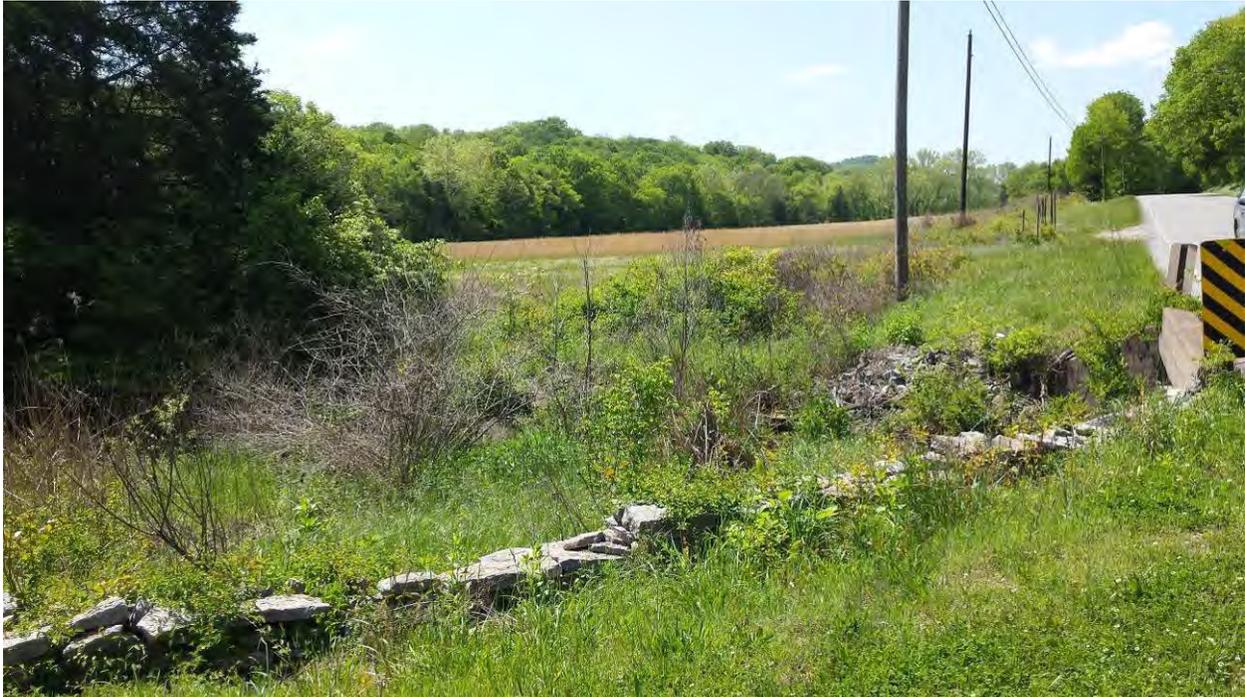
Description:	View of VSA Site 20 facing east.
---------------------	----------------------------------

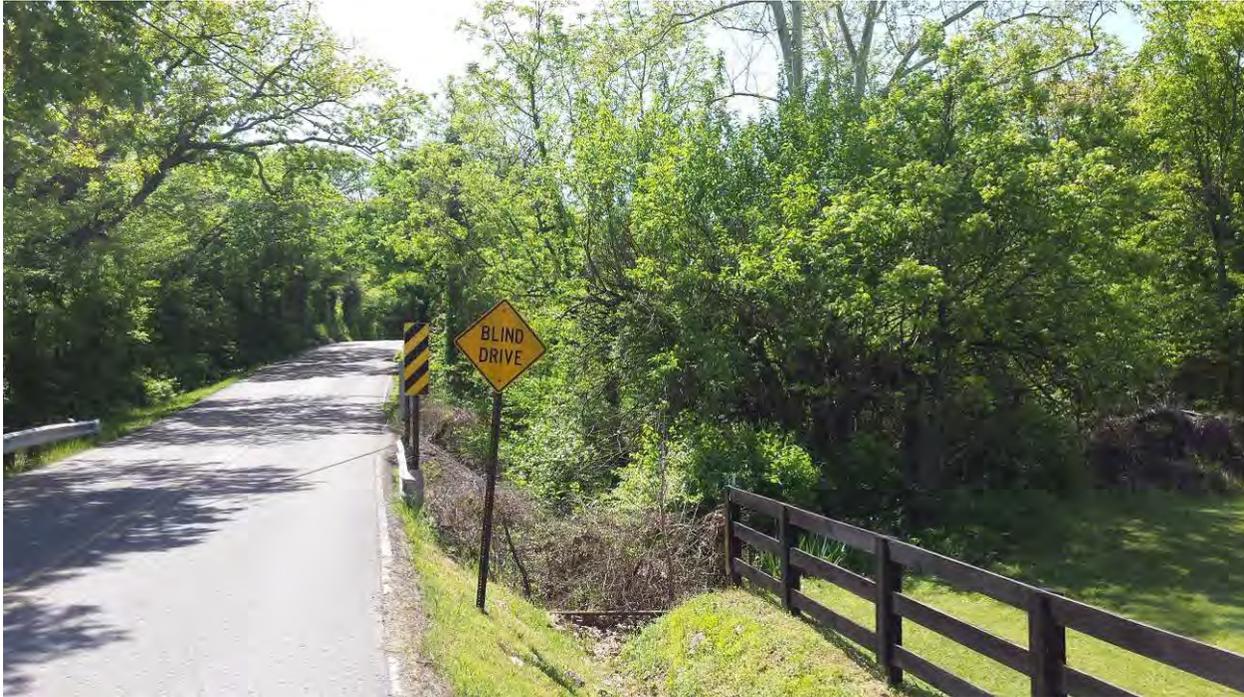
Description:	View of VSA Site 21, Owl Creek at Pleasant Hill Road which is a representative site. Photograph taken facing south along Pleasant Hill Road.
---------------------	--

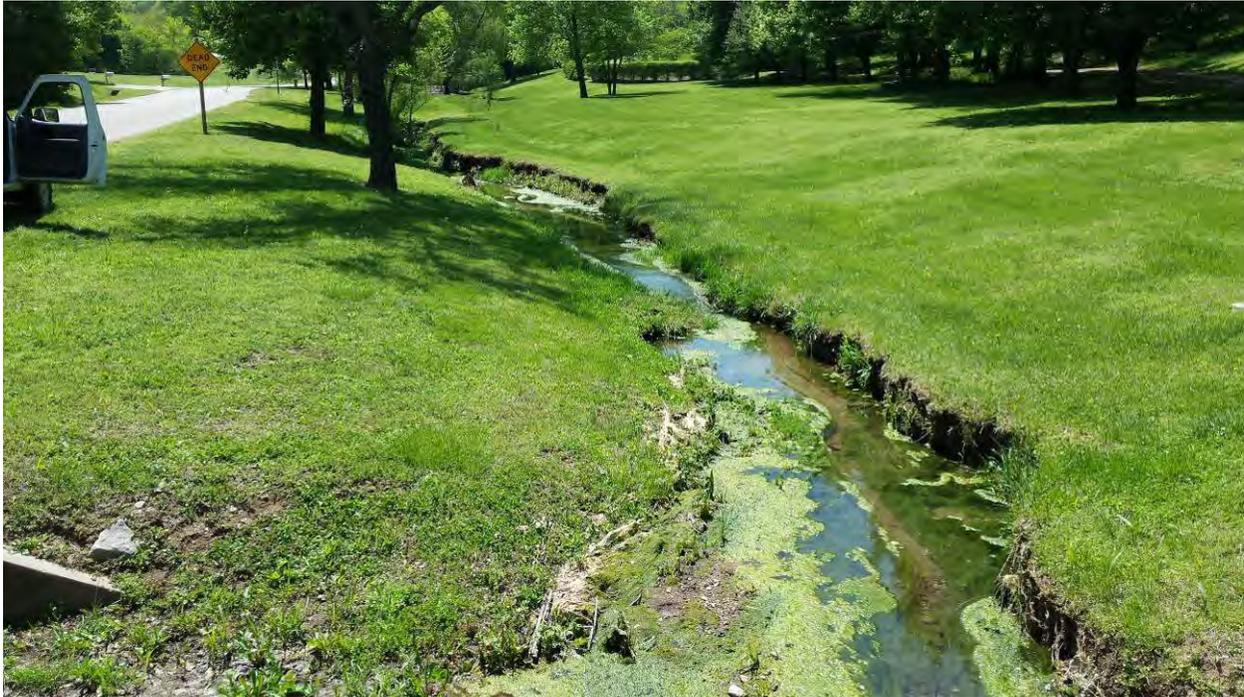
Description:	View of VSA Site 22, Owl Creek at Vernon Road with excessive algae in creek bed and downcutting of creek banks.
---------------------	---

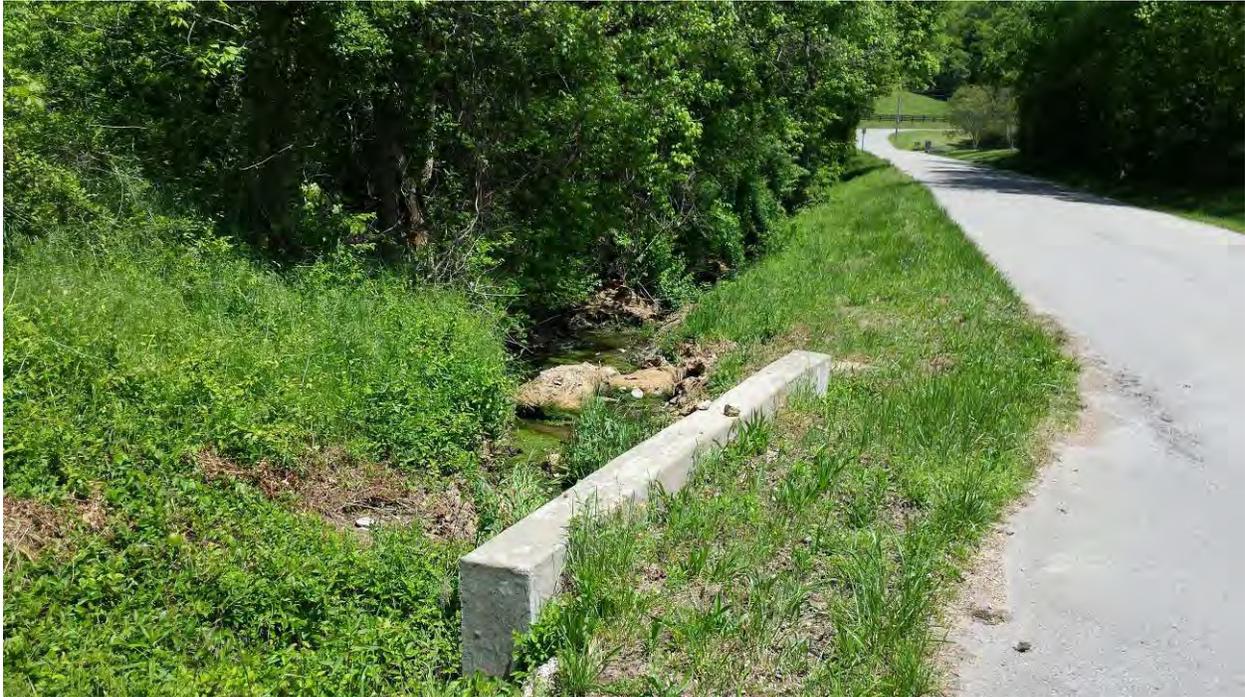
Description:	View of VSA Site 22 with showing creek channel blockage and slight headwall erosion.
---------------------	--

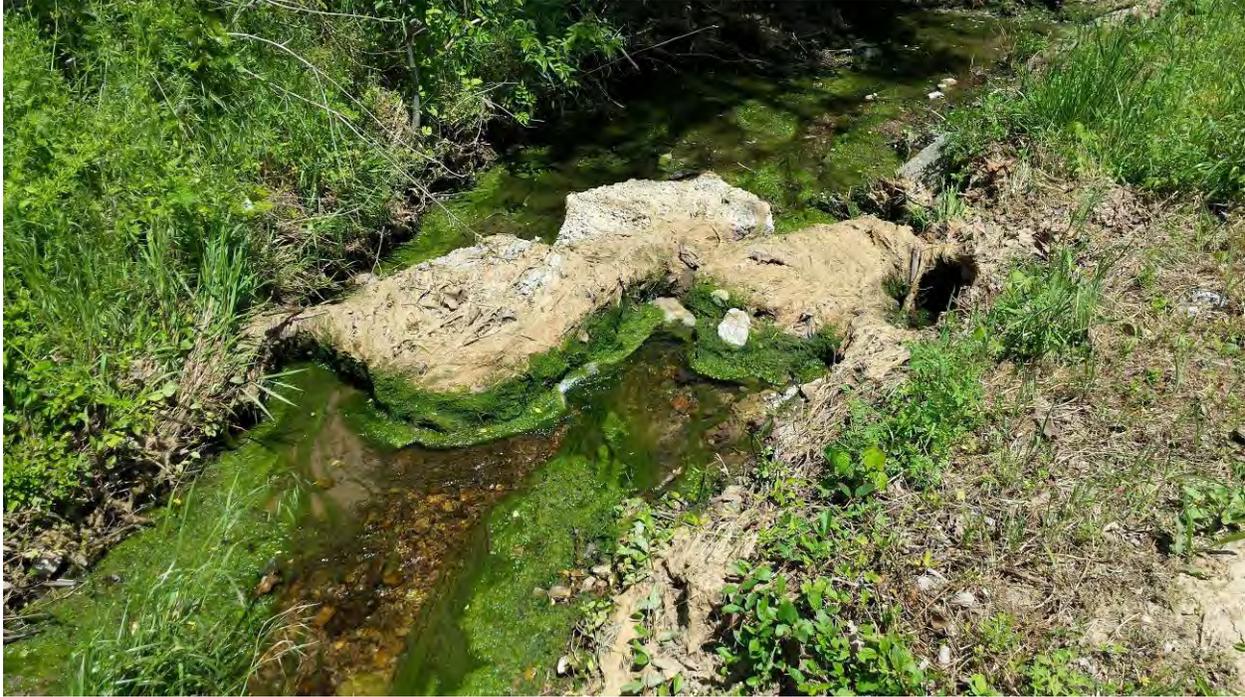
Description:	Close-up view of creek blockage at VSA Site 22.
---------------------	---

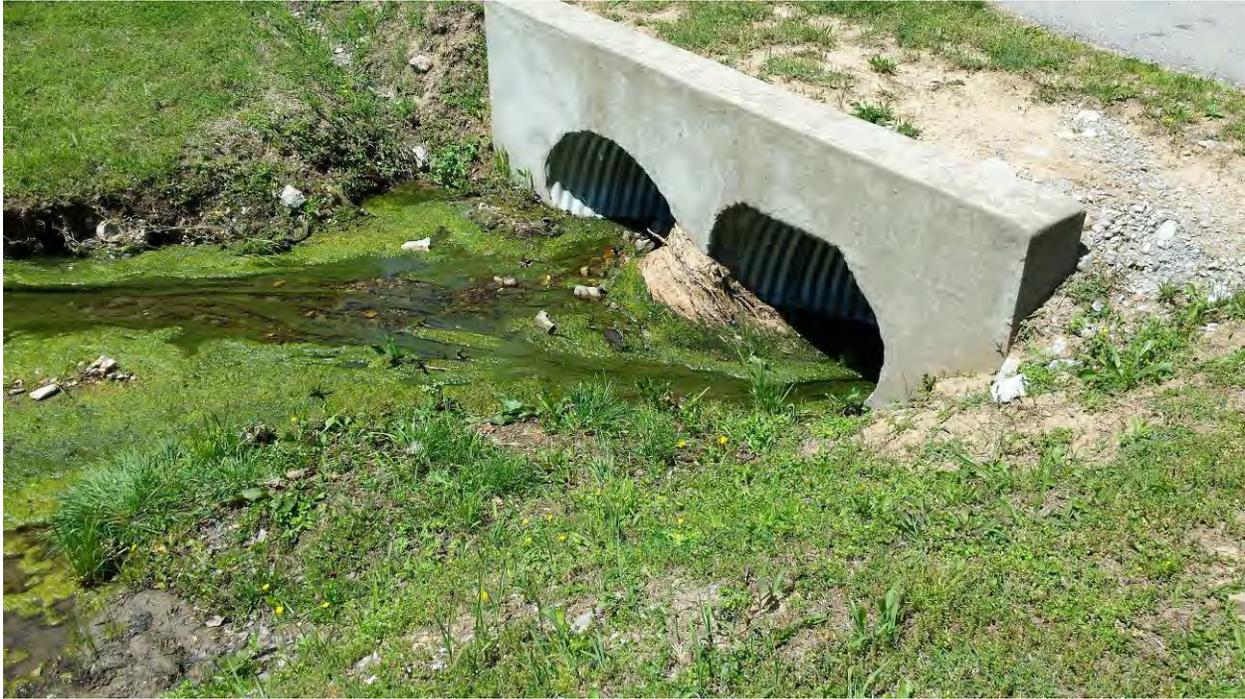
Description:	View of VSA Site 22, Owl Creek at Vernon Road, showing algae in the stream and build up around the road.
---------------------	--

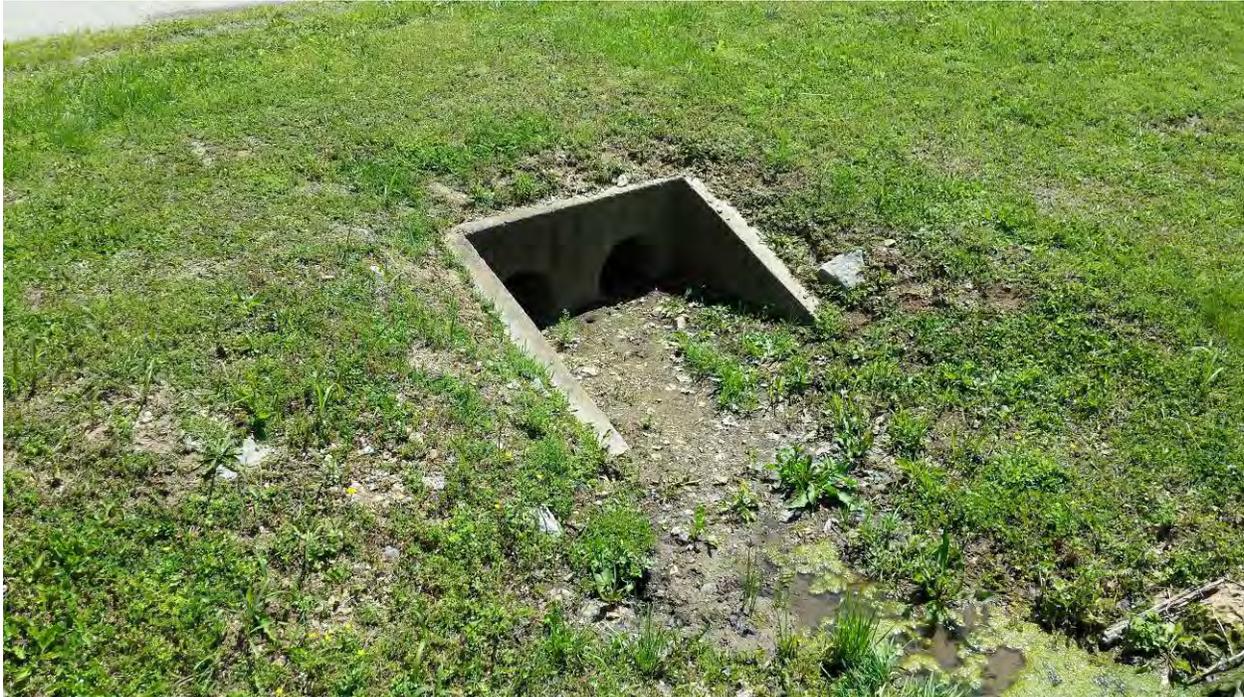
Description:	View of VSA Site 22 showing sedimentation at the culverts that is blocking stream flow.
---------------------	---

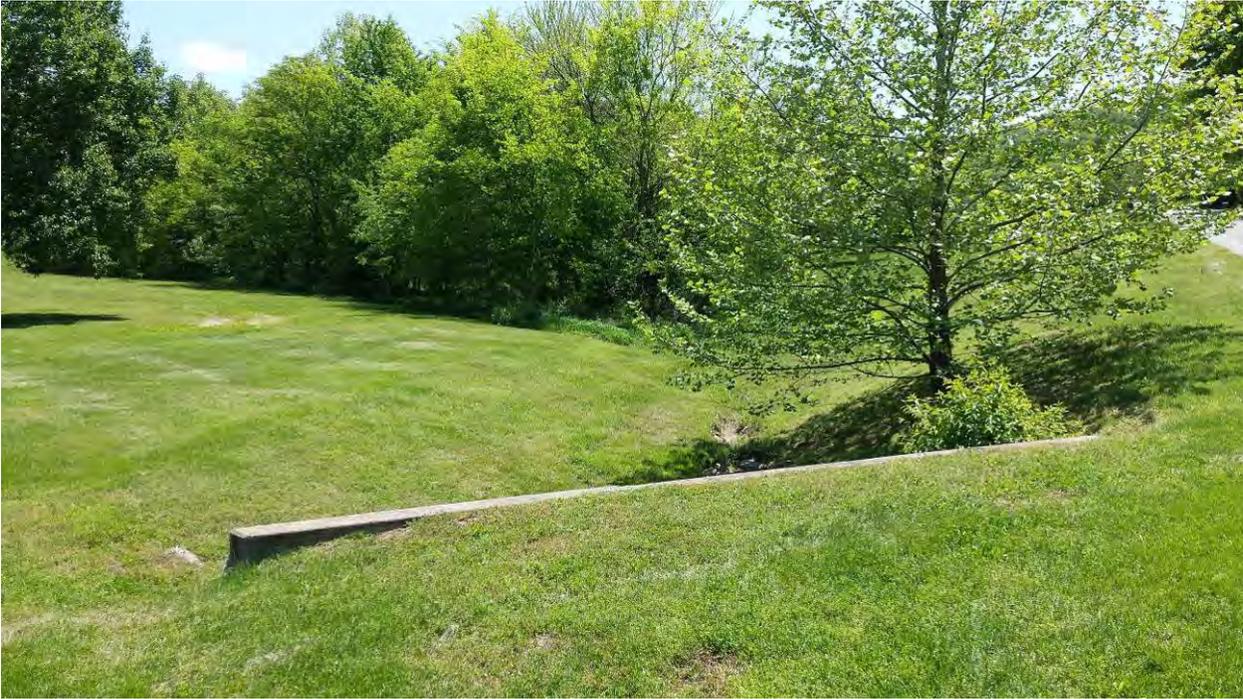
Description:	View of VSA Site 23, west of Whistler Cove. The creek banks appear to be mowed as a residential lawn.
---------------------	---

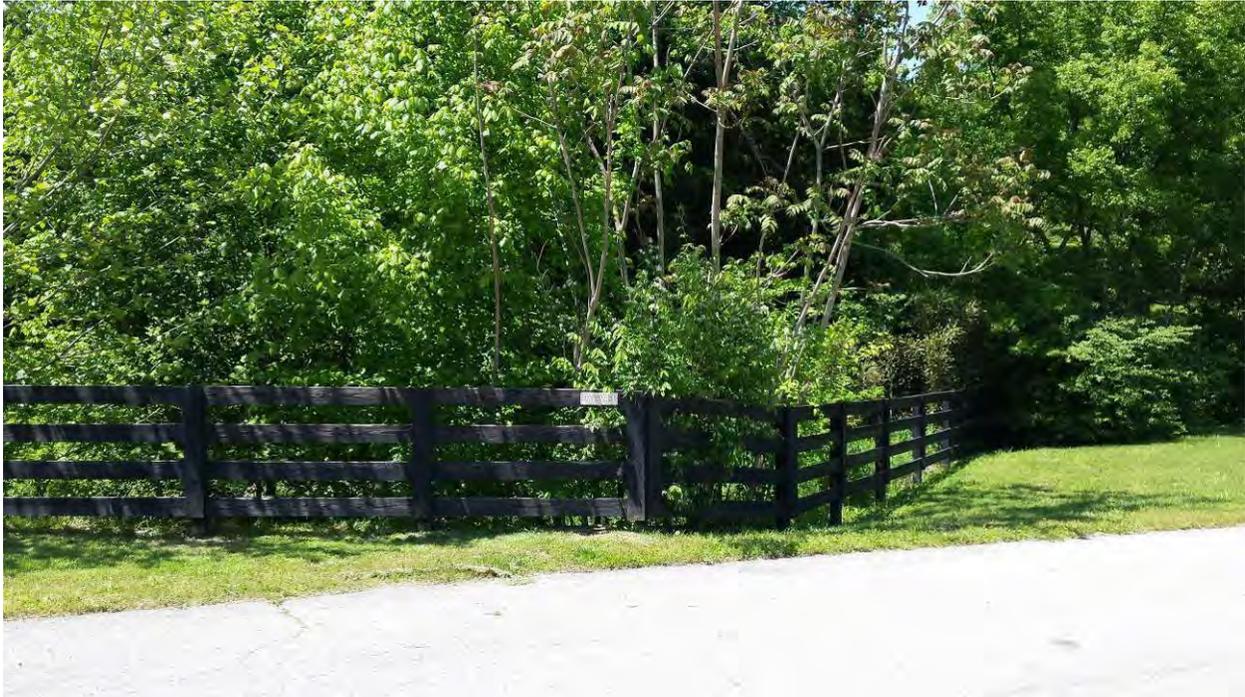
View of VSA Site 23, to the east of Whistler Cove that has a wider riparian buffer beyond the residential fence.
